# Access Compliance Report

## Public Rights-of-Way

### (Curb Ramps)

Intersection ID: 11208	Main Street: PARKWOOD_AV	Cross Street: N_BREVARD_ST	Location: NE
ADA ID: 12DB6031C5AE	Ramp Type: Perp	Initial Pass/Fail: Fail	Overall Compliance: No
Severity Score: 13.75			
Codes/Mitigation Info/Possible Solution		Field Measurements/Component Compliance

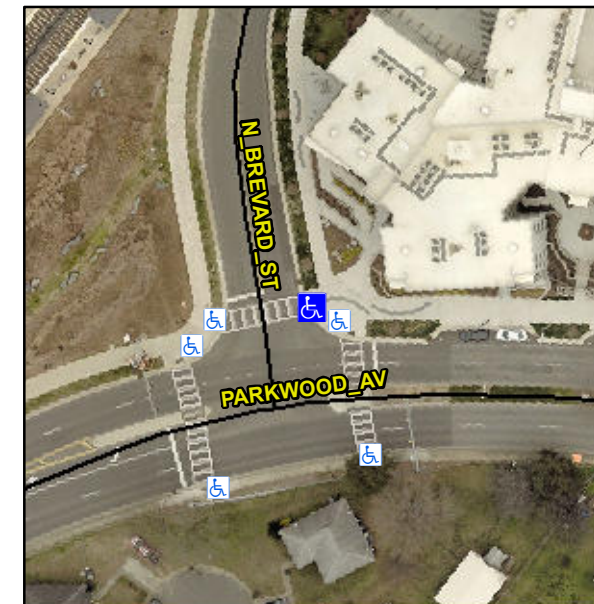
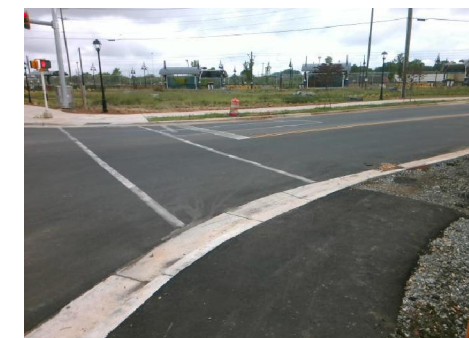
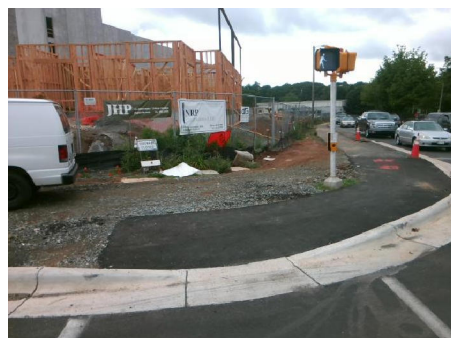
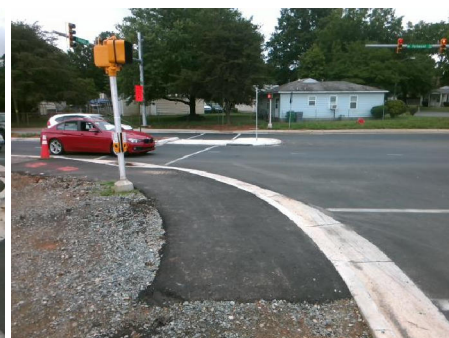
**Not Found, R304.2.2, R304.5.3**

Compliance	Description	Data	Compliance	Description	Data
N/A	Ramp Length (in)	78.0	No	Ramp Slope (%)	9.3
Yes	Ramp Width (in)	48.0	No	Ramp XSlope (%)	2.5
N/A	Flare Type LT	N/A	N/A	Flare Type RT	N/A
N/A	Flare Slope LT (%)	N/A	N/A	Flare Slope RT (%)	N/A
N/A	Flare Traversable LT?	N/A	N/A	Flare Traversable RT?	N/A
N/A	Landing Length (in)	N/A	N/A	DWS Provided?	N/A
N/A	Landing Width (in)	N/A	N/A	DWS Contrast?	N/A
N/A	Landing Slope (%)	N/A	N/A	DWS Length (in)	N/A
N/A	Landing X Slope (%)	N/A	N/A	DWS Full Width?	N/A
N/A	Landing Curb? (Y/N)	N/A	N/A	DWS Offset (in)	N/A
N/A	Shared Landing?	N/A			
N/A	Gutter Ponding?	N/A	N/A	Gutter Slope (%)	N/A
N/A	Gutter Lip Ht (in)	N/A	N/A	Gutter X Slope (%)	N/A
N/A	Painted X Walk1?	Yes	N/A	Painted X Walk2?	N/A
	X Walk 1 Direction	To W		X Walk 2 Direction	N/A
N/A	X Walk 1 Width (in)	113.0	N/A	X Walk 2 Width (in)	N/A
	X Walk 1 Slope (%)	1.7		X Walk 2 Slope (%)	N/A
	X Walk 1 X Slope (%)	1.7		X Walk 2 X Slope (%)	N/A

N/A	Ramp inside XWalk1?	Yes	N/A	Ramp inside XWalk2?	N/A
	Road Slope (%)	N/A	N/A	Clear Space?	N/A
	Road X Slope (%)	N/A	N/A	Clear Space to XWalk (in)	N/A
N/A	Any Obstructions?	N/A	N/A	Storm Grate/Utility Hazard?	N/A
	Obstruction Type			Storm Grate/Utility Type	
		N/A			N/A
		Yes		Surface Condition? (G/P)	Good

**Remove & Replace Entire Ramp.**
