# Access Compliance Report

## Public Rights-of-Way

Intersection ID: 12809	Main Street: N_MCDOWELL_ST	Cross Street: E_7TH_ST	Location: S
ADA ID: 12DE34372103	Ramp Type: PerpDiag	Initial Pass/Fail: Pass	Overall Compliance: No
Severity Score: 2.75			
Codes/Mitigation Info/Possible Solution		Field Measurements/Component Compliance

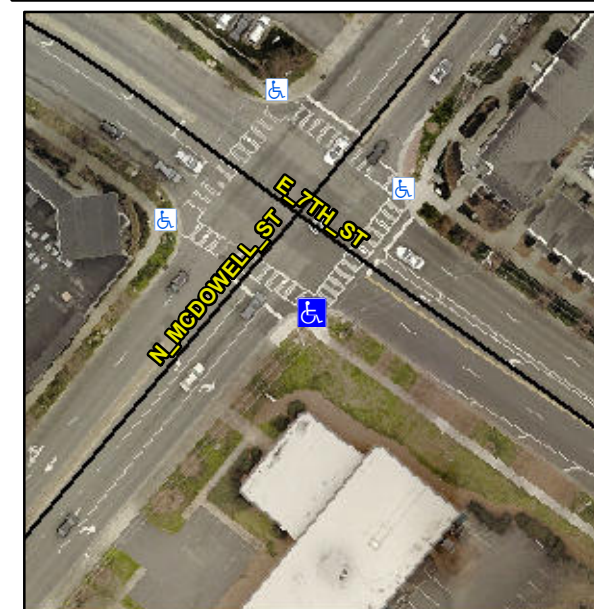
**Not Found, R304.5.3, R304.2.3**

Compliance	Description	Data	Compliance	Description	Data
N/A	Ramp Length (in)	89.0	Yes	Ramp Slope (%)	5.2
Yes	Ramp Width (in)	96.0	No	Ramp XSlope (%)	4.5
N/A	Flare Type LT	Sloped	N/A	Flare Type RT	N/A
N/A	Flare Slope LT (%)	10.4	Yes	Flare Slope RT (%)	3.0
N/A	Flare Traversable LT?	Yes	N/A	Flare Traversable RT?	Yes
Yes	Landing Length (in)	60.0	Yes	DWS Provided?	Yes
Yes	Landing Width (in)	60.0	Yes	DWS Contrast?	Yes
Yes	Landing Slope (%)	2.0	Yes	DWS Length (in)	24.0
Yes	Landing X Slope (%)	0.2	Yes	DWS Full Width?	Yes
N/A	Landing Curb? (Y/N)	No	Yes	DWS Offset (in)	0.0
N/A	Shared Landing?	N/A			
Yes	Gutter Ponding?	No	Yes	Gutter Slope (%)	0.7
Yes	Gutter Lip Ht (in)	0.0	No	Gutter X Slope (%)	4.0
N/A	Painted X Walk1?	Yes	N/A	Painted X Walk2?	Yes
	X Walk 1 Direction	To NE		X Walk 2 Direction	To NW
N/A	X Walk 1 Width (in)	111.0	N/A	X Walk 2 Width (in)	110.0
	X Walk 1 Slope (%)	5.3		X Walk 2 Slope (%)	3.3
	X Walk 1 X Slope (%)	4.5		X Walk 2 X Slope (%)	4.0

Yes	Ramp inside XWalk1?	Yes	Yes	Ramp inside XWalk2?	Yes
	Road Slope (%)	0.1	N/A	Clear Space?	Yes
	Road X Slope (%)	6.5	Yes	Clear Space to XWalk (in)	96.0
Yes	Any Obstructions?	No	Yes	Storm Grate/Utility Hazard?	No
	Obstruction Type			Storm Grate/Utility Type	
		N/A			N/A
			Yes	Surface Condition? (G/P)	Good

**Remove & Replace Curb Ramp With Two New Directional Ramps or Equivalent. Remove & Replace Gutter.**

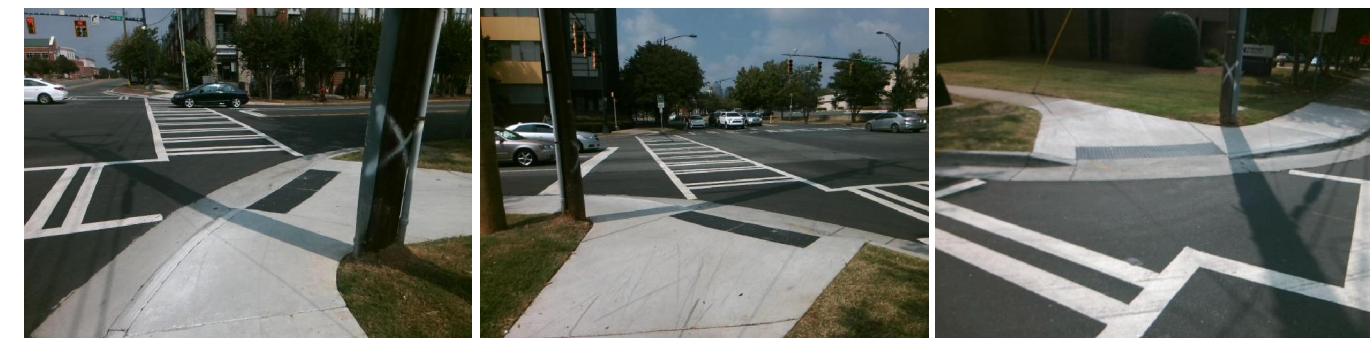
Street 1 Name E 7TH ST  
 Stop Condition-Street 2 Signal  
 Street 2 Name N MCDOWELL ST  
 Stop Condition-Street 1 Signal

Possible Solutions:
