# Access Compliance Report

## Public Rights-of-Way

### (Curb Ramps)

| Intersection ID: 16436 | Main Street: HAMPTON_AV | Cross Street: PORTLAND_AV | Location: SE |

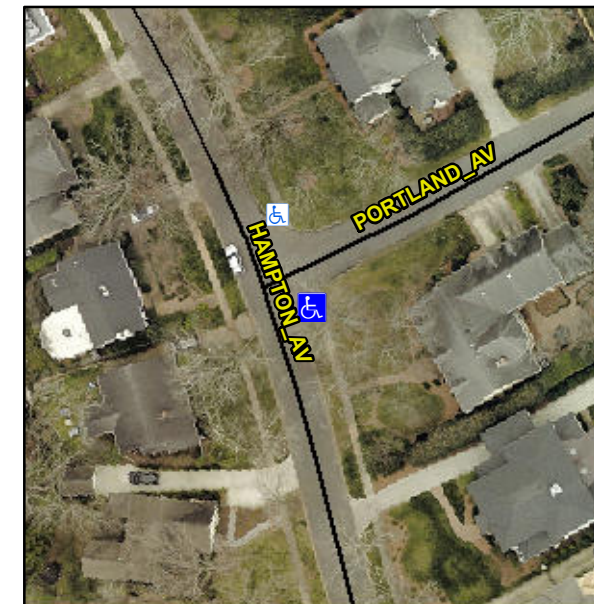
**Not Found, R304.2.1, R304.2.2-Perp, R304.3.2-Para, R304.5.3, R305, R302.7.2**

| Compliance | Description | Data | Compliance | Description | Data |
|---|---|---|---|---|---|
| No | Landing Length (in) | N/A | No | DWS Provided? | No |
| No | Gutter Lip Ht (in) | 0.5 | No | Gutter X Slope (%) | 2.1 |

**Remove & Replace Curb Ramp With Two New Directional Ramps or Equivalent. Remove & Replace Gutter.**
