Access Compliance Report

Public Rights-of-Way

(Curb Ramps)

Intersection ID: 50023	Main Street: SPRINGFIELD_GARDENS_DR	Cross Street: WYALONG_DR	Location: SE
ADA ID: 12F13999381A	Ramp Type: Perp	Initial Pass/Fail: Fail	Overall Compliance: No
Severity Score: 12.5			
Codes/Mitigation Info/Possible Solution		Field Measurements/Component Compliance

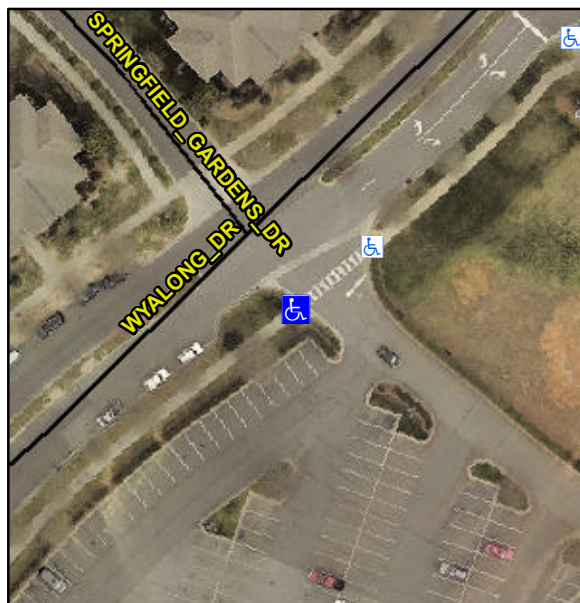
Not Found, R304.2.2

Compliance	Description	Data	Compliance	Description	Data
N/A	Ramp Length (in)	108.0	No	Ramp Slope (%)	8.4
Yes	Ramp Width (in)	71.0	Yes	Ramp XSlope (%)	1.4
N/A	Flare Type LT	N/A	N/A	Flare Type RT	N/A
N/A	Flare Slope LT (%)	N/A	N/A	Flare Slope RT (%)	N/A
N/A	Flare Traversable LT?	N/A	N/A	Flare Traversable RT?	N/A
N/A	Landing Length (in)	N/A	N/A	DWS Provided?	N/A
N/A	Landing Width (in)	N/A	N/A	DWS Contrast?	N/A
N/A	Landing Slope (%)	N/A	N/A	DWS Length (in)	N/A
N/A	Landing X Slope (%)	N/A	N/A	DWS Full Width?	N/A
N/A	Landing Curb? (Y/N)	N/A	N/A	DWS Offset (in)	N/A
N/A	Shared Landing?	N/A			
N/A	Gutter Ponding?	N/A	N/A	Gutter Slope (%)	N/A
N/A	Gutter Lip Ht (in)	N/A	N/A	Gutter X Slope (%)	N/A
N/A	Painted X Walk1?	Yes	N/A	Painted X Walk2?	N/A
	X Walk 1 Direction	To NE		X Walk 2 Direction	N/A
N/A	X Walk 1 Width (in)	70.0	N/A	X Walk 2 Width (in)	N/A
	X Walk 1 Slope (%)	3.2		X Walk 2 Slope (%)	N/A
	X Walk 1 X Slope (%)	3.4		X Walk 2 X Slope (%)	N/A

N/A	Ramp inside XWalk1?	Yes	N/A	Ramp inside XWalk2?	N/A
	Road Slope (%)	N/A	N/A	Clear Space?	N/A
	Road X Slope (%)	N/A	N/A	Clear Space to XWalk (in)	N/A
N/A	Any Obstructions?	N/A	N/A	Storm Grate/Utility Hazard?	N/A
	Obstruction Type			Storm Grate/Utility Type	
		N/A			N/A
			Yes	Surface Condition? (G/P)	Good

Remove & Replace Entire Ramp.
