Access Compliance Report Public Rights-of-Way (Curb Ramps)

Intersection ID: 8087Main Street:BROOKWAY_DRCross Street:S_HOSKINS_RDLocation:NWADA ID: 12FD749FB900Ramp Type:BlendTrans1Initial Pass/Fail:FailOverall Compliance:NoSeverity Score:10

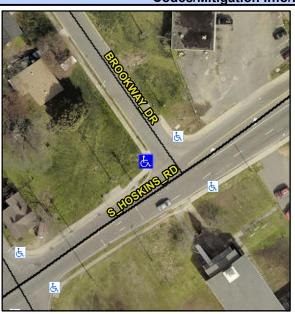
LT RP < 5%

Not Found, R304.5.1, R304.5.3

Field Measurements/Component Compilance					
Compliance Description		Data	Compliance Description		Data
N/A	Ramp Length (in)	25.0	Yes	BlendTrans Slope (%)	4.2
No	Ramp Width (in)	47.0	No	BlendTrans XSlope (%)	3.2
N/A	Flare Type LT	N/A	N/A	Flare Type RT	N/A
N/A	Flare Slope LT (%)	N/A	N/A	Flare Slope RT (%)	N/A
N/A	Flare Traversable LT?	N/A	N/A	Flare Traversable RT?	N/A
N/A	Landing Length (in)	N/A	N/A	DWS Provided?	N/A
N/A	Landing Width (in)	N/A	N/A	DWS Contrast?	N/A
N/A	Landing Slope (%)	N/A	N/A	DWS Length (in)	N/A
N/A	Landing X Slope (%)	N/A	N/A	DWS Full Width?	N/A
N/A	Landing Curb? (Y/N)	N/A	N/A	DWS Offset (in)	N/A
N/A	Shared Landing?	N/A			
N/A	Gutter Ponding?	N/A	N/A	Gutter Slope (%)	N/A
N/A	Gutter Lip Ht (in)	N/A	N/A	Gutter X Slope (%)	N/A
N/A	Painted X Walk1?	No	N/A	Painted X Walk2?	No
	X Walk 1 Direction	To SE		X Walk 2 Direction	To NE
	X Walk 1 Width (in)	N/A		X Walk 2 Width (in)	N/A
	X Walk 1 Slope (%)	1.1		X Walk 2 Slope (%)	4.5

X Walk 1 X Slope (%)	3.4		X Walk 2 X Slope (%)	1.3
N/A	Ramp inside XWalk1?	N/A	N/A	Ramp inside XWalk2?	N/A
	Road Slope (%)	3.0		Clear Space?	N/A
	Road X Slope (%)	3.4	N/A	Clear Space to XWalk (in)	N/A
N/A	Any Obstructions?	N/A	N/A	Storm Grate/Utility Hazard?	N/A
	Obstruction Type			Storm Grate/Utility Type

Remove & Replace Curb Ramp With
Two New Directional Ramps or
Equivalent.
