Access Compliance Report

Public Rights-of-Way

(Curb Ramps)

Intersection ID: 31705	Main Street: ATLAS_CEDAR_DR	Cross Street: CARPENTARIA_CT	Location: NW
ADA ID: 12FD903ECCB1	Ramp Type: PerpDiag	Initial Pass/Fail: Fail	Overall Compliance: No
Severity Score: 10			
Codes/Mitigation Info/Possible Solution		Field Measurements/Component Compliance

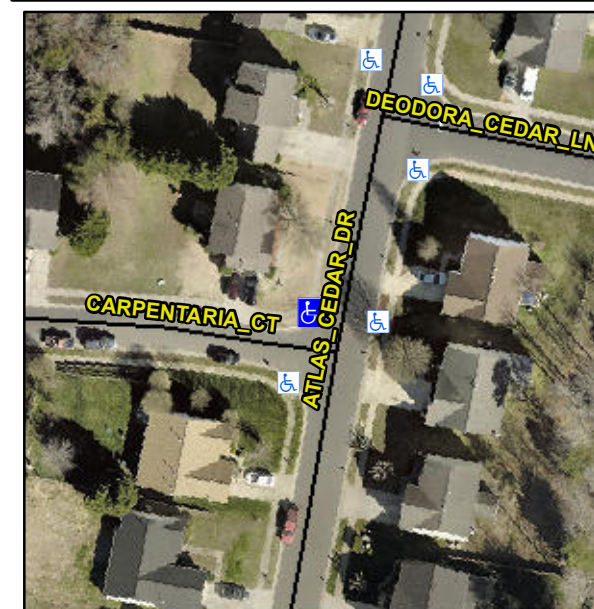
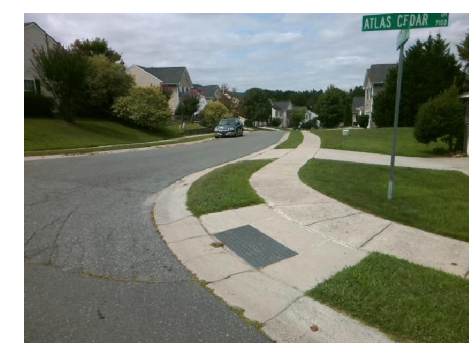
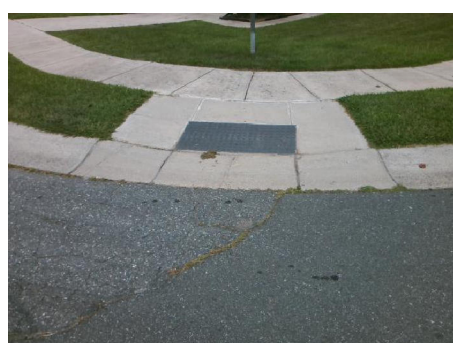
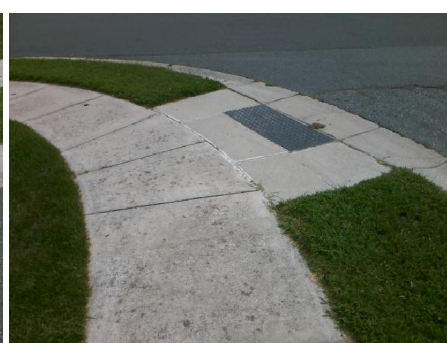
Not Found, R304.5.1, R304.5.3

Compliance	Description	Data	Compliance	Description	Data
N/A	Ramp Length (in)	47.0	Yes	Ramp Slope (%)	7.7
No	Ramp Width (in)	43.5	No	Ramp XSlope (%)	3.8
N/A	Flare Type LT	N/A	N/A	Flare Type RT	N/A
N/A	Flare Slope LT (%)	N/A	N/A	Flare Slope RT (%)	N/A
N/A	Flare Traversable LT?	N/A	N/A	Flare Traversable RT?	N/A
N/A	Landing Length (in)	N/A	N/A	DWS Provided?	N/A
N/A	Landing Width (in)	N/A	N/A	DWS Contrast?	N/A
N/A	Landing Slope (%)	N/A	N/A	DWS Length (in)	N/A
N/A	Landing X Slope (%)	N/A	N/A	DWS Full Width?	N/A
N/A	Landing Curb? (Y/N)	N/A	N/A	DWS Offset (in)	N/A
N/A	Shared Landing?	N/A			
N/A	Gutter Ponding?	N/A	N/A	Gutter Slope (%)	N/A
N/A	Gutter Lip Ht (in)	N/A	N/A	Gutter X Slope (%)	N/A
N/A	Painted X Walk1?	No	N/A	Painted X Walk2?	No
	X Walk 1 Direction	To SE		X Walk 2 Direction	To SW
N/A	X Walk 1 Width (in)	N/A	N/A	X Walk 2 Width (in)	N/A
	X Walk 1 Slope (%)	7.5		X Walk 2 Slope (%)	4.7
	X Walk 1 X Slope (%)	1.9		X Walk 2 X Slope (%)	7.7

N/A	Ramp inside XWalk1?	N/A	N/A	Ramp inside XWalk2?	N/A
	Road Slope (%)	2.4	N/A	Clear Space?	N/A
	Road X Slope (%)	9.2	N/A	Clear Space to XWalk (in)	N/A
N/A	Any Obstructions?	N/A	N/A	Storm Grate/Utility Hazard?	N/A
	Obstruction Type			Storm Grate/Utility Type	
		N/A			N/A
			Yes	Surface Condition? (G/P)	Good

Remove & Replace Curb Ramp With Two New Directional Ramps or Equivalent.
