Access Compliance Report

Public Rights-of-Way

(Curb Ramps)

Intersection ID: 15111	Main Street: SHEFFIELD_DR	Cross Street: TARRINGTON_AV	Location:	E
ADA ID: 12FDE802026E	Ramp Type: Perp	Initial Pass/Fail: Fail	Overall Compliance: No	Severity Score: 10
Codes/Mitigation Info/Possible Solution		Field Measurements/Component Compliance

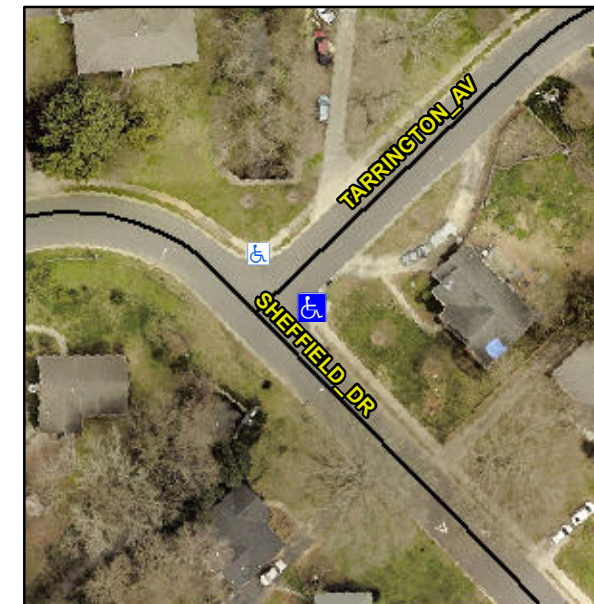
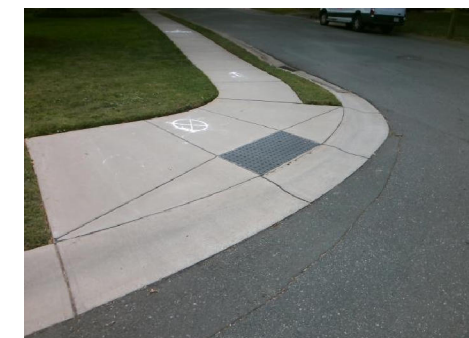
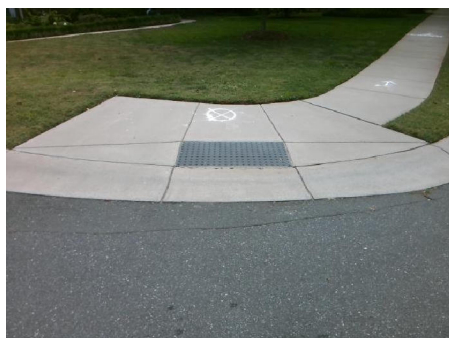
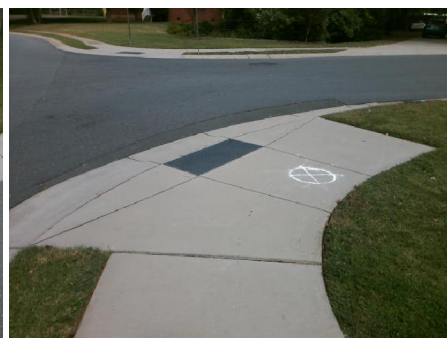
Compliance	Description	Data	Compliance	Description	Data
N/A	Ramp Length (in)	82.0	Yes	Ramp Slope (%)	5.4
No	Ramp Width (in)	37.0	No	Ramp XSlope (%)	2.8
N/A	Flare Type LT	N/A	N/A	Flare Type RT	N/A
N/A	Flare Slope LT (%)	N/A	N/A	Flare Slope RT (%)	N/A
N/A	Flare Traversable LT?	N/A	N/A	Flare Traversable RT?	N/A
N/A	Landing Length (in)	N/A	N/A	DWS Provided?	N/A
N/A	Landing Width (in)	N/A	N/A	DWS Contrast?	N/A
N/A	Landing Slope (%)	N/A	N/A	DWS Length (in)	N/A
N/A	Landing X Slope (%)	N/A	N/A	DWS Full Width?	N/A
N/A	Landing Curb? (Y/N)	N/A	N/A	DWS Offset (in)	N/A
N/A	Shared Landing?	N/A			
N/A	Gutter Ponding?	N/A	N/A	Gutter Slope (%)	N/A
N/A	Gutter Lip Ht (in)	N/A	N/A	Gutter X Slope (%)	N/A
N/A	Painted X Walk1?	No	N/A	Painted X Walk2?	N/A
	X Walk 1 Direction	To NW		X Walk 2 Direction	N/A
N/A	X Walk 1 Width (in)	N/A	N/A	X Walk 2 Width (in)	N/A
	X Walk 1 Slope (%)	2.0		X Walk 2 Slope (%)	N/A
	X Walk 1 X Slope (%)	1.6		X Walk 2 X Slope (%)	N/A

N/A	Ramp inside XWalk1?	N/A	N/A	Ramp inside XWalk2?	N/A
	Road Slope (%)	N/A	N/A	Clear Space?	N/A
	Road X Slope (%)	N/A	N/A	Clear Space to XWalk (in)	N/A
N/A	Any Obstructions?	N/A	N/A	Storm Grate/Utility Hazard?	N/A
	Obstruction Type			Storm Grate/Utility Type	
		N/A			N/A
			Yes	Surface Condition? (G/P)	Good

Possible Solutions:

Remove & Replace Entire Ramp.
