Access Compliance Report

Public Rights-of-Way

(Curb Ramps)

Intersection ID: 10370	Main Street: SOLOMON_ST	Cross Street: W_TRADE_ST	Location:	N/A
ADA ID: 1300C238D958	Ramp Type: Perp	Initial Pass/Fail: Fail	Overall Compliance: No	Severity Score: 8.75

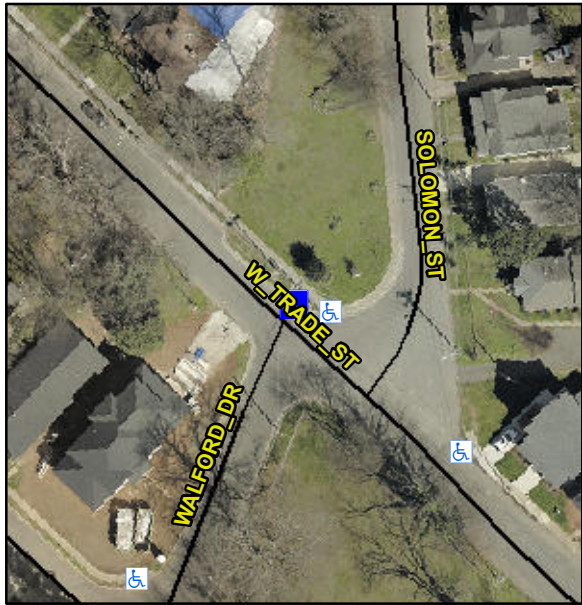
Possible Solutions:		Compliance	Description	Data	Compliance	Description	Data
	Remove & Replace Entire Ramp.		N/A	Ramp Length (in)	75.0	Yes	Ramp Slope (%)	7.5
			No	Ramp Width (in)	42.0	Yes	Ramp XSlope (%)	0.0
			N/A	Flare Type LT	N/A	N/A	Flare Type RT	N/A
			N/A	Flare Slope LT (%)	N/A	N/A	Flare Slope RT (%)	N/A
			N/A	Flare Traversable LT?	N/A	N/A	Flare Traversable RT?	N/A
			N/A	Landing Length (in)	N/A	N/A	DWS Provided?	N/A
			N/A	Landing Width (in)	N/A	N/A	DWS Contrast?	N/A
			N/A	Landing Slope (%)	N/A	N/A	DWS Length (in)	N/A
			N/A	Landing X Slope (%)	N/A	N/A	DWS Full Width?	N/A
Surveyor Notes:	N/A		N/A	Landing Curb? (Y/N)	N/A	N/A	DWS Offset (in)	N/A
			N/A	Shared Landing?	N/A			
	PROW/ADA:		N/A	Gutter Ponding?	N/A	N/A	Gutter Slope (%)	N/A
	Not Found, R304.5.1		N/A	Gutter Lip Ht (in)	N/A	N/A	Gutter X Slope (%)	N/A

N/A	Painted X Walk1?	No	N/A	Painted X Walk2?	N/A
				X Walk 1 Direction	To W		X Walk 2 Direction	N/A
			N/A	X Walk 1 Width (in)	N/A	N/A	X Walk 2 Width (in)	N/A
				X Walk 1 Slope (%)	1.2		X Walk 2 Slope (%)	N/A
				X Walk 1 X Slope (%)	0.2		X Walk 2 X Slope (%)	N/A
			N/A	Ramp inside XWalk1?	N/A	N/A	Ramp inside XWalk2?	N/A
Total Cost:				Road Slope (%)	0.2	N/A	Clear Space?	N/A
				Road X Slope (%)	1.2	N/A	Clear Space to XWalk (in)	N/A
			N/A	Any Obstructions?	N/A	N/A	Storm Grate/Utility Hazard?	N/A
				Obstruction Type			Storm Grate/Utility Type	
					N/A			N/A
					Yes	Surface Condition? (G/P)	Good
