# Access Compliance Report

## Public Rights-of-Way

### (Curb Ramps)

| Intersection ID: 54366 | Main Street: CADEN_RD | Cross Street: COLLINS_FORD_RD | Location: W |

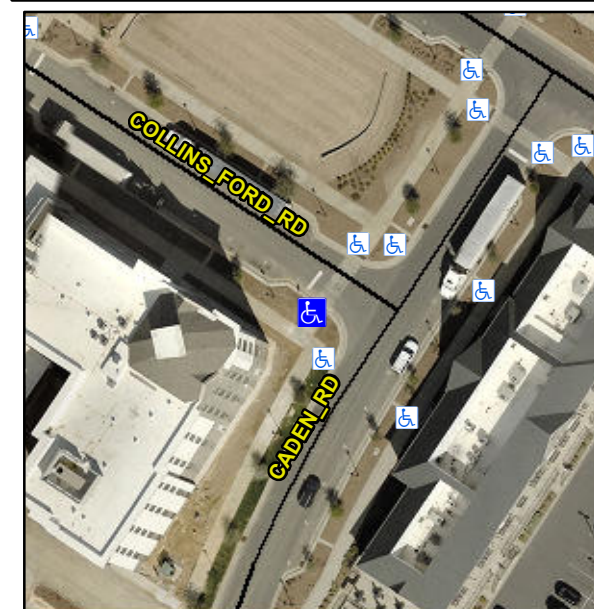
**Not Found, R304.5.3**

| Compliance | Description | Data | Compliance | Description | Data |
|---|---|---|---|---|---|
| Yes | Ramp Width (in) | 93.0 | No | BlendTrans XSlope (%) | 4.0 |
| | | | No | Curb Slope (%) | 14.4 |

**Remove & Replace Curb Ramp With Two New Directional Ramps or Equivalent.**
