# Access Compliance Report

## Public Rights-of-Way

### (Curb Ramps)

Intersection ID: 48496	Main Street: LOCH_LOMOND_DR	Cross Street: CASTLECOVE_RD	Location: E
ADA ID: 131C97D3E1BD	Ramp Type: PerpDiag	Initial Pass/Fail: Fail	Overall Compliance: No
Codes/Mitigation Info/Possible Solution		Field Measurements/Component Compliance

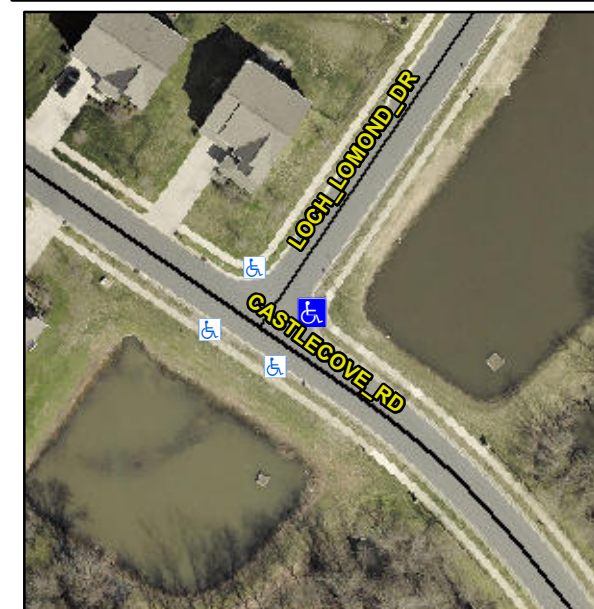
Compliance	Description	Data	Compliance	Description	Data
N/A	Ramp Length (in)	48.0	No	Ramp Slope (%)	10.3
No	Ramp Width (in)	45.5	Yes	Ramp XSlope (%)	0.5
N/A	Flare Type LT	N/A	N/A	Flare Type RT	N/A
N/A	Flare Slope LT (%)	N/A	N/A	Flare Slope RT (%)	N/A
N/A	Flare Traversable LT?	N/A	N/A	Flare Traversable RT?	N/A
N/A	Landing Length (in)	N/A	N/A	DWS Provided?	N/A
N/A	Landing Width (in)	N/A	N/A	DWS Contrast?	N/A
N/A	Landing Slope (%)	N/A	N/A	DWS Length (in)	N/A
N/A	Landing X Slope (%)	N/A	N/A	DWS Full Width?	N/A
N/A	Landing Curb? (Y/N)	N/A	N/A	DWS Offset (in)	N/A
N/A	Shared Landing?	N/A			
N/A	Gutter Ponding?	N/A	N/A	Gutter Slope (%)	N/A
N/A	Gutter Lip Ht (in)	0.5	N/A	Gutter X Slope (%)	N/A
N/A	Painted X Walk1?	No	N/A	Painted X Walk2?	No
	X Walk 1 Direction	To NW		X Walk 2 Direction	To SW
N/A	X Walk 1 Width (in)	N/A	N/A	X Walk 2 Width (in)	N/A
	X Walk 1 Slope (%)	0.8		X Walk 2 Slope (%)	2.4
	X Walk 1 X Slope (%)	0.7		X Walk 2 X Slope (%)	0.6

N/A	Ramp inside XWalk1?	N/A	N/A	Ramp inside XWalk2?	N/A
	Road Slope (%)	1.2	N/A	Clear Space?	N/A
	Road X Slope (%)	0.8	N/A	Clear Space to XWalk (in)	N/A
N/A	Any Obstructions?	N/A	N/A	Storm Grate/Utility Hazard?	N/A
	Obstruction Type			Storm Grate/Utility Type	
		N/A			N/A
			Yes	Surface Condition? (G/P)	Good

**Remove & Replace Curb Ramp With Two New Directional Ramps or Equivalent.**

**R304.5.1, R304.2.2**
