# Access Compliance Report

## Public Rights-of-Way

### (Curb Ramps)

Intersection ID: 46308	Main Street: DONNEGAL_FARM_RD	Cross Street: BECKET RIDGE_RD	Location: SE
ADA ID: 131DB5536225	Ramp Type: Perp	Initial Pass/Fail: Fail	Overall Compliance: No
		Severity Score: 10

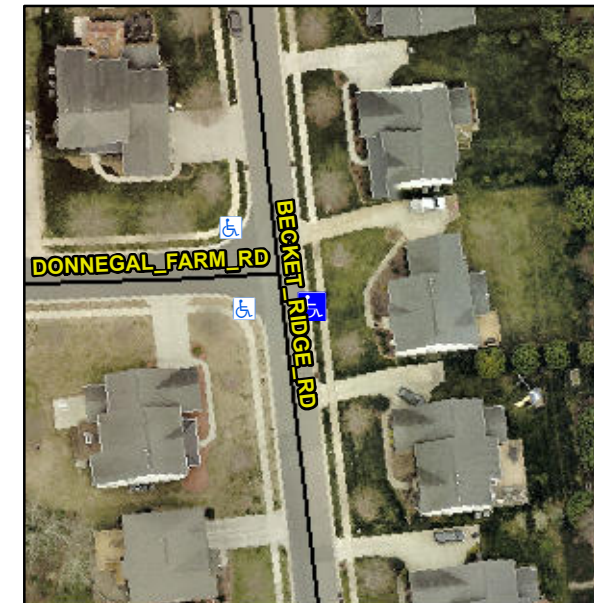
**Not Found, R304.5.1**

Compliance	Description	Data	Compliance	Description	Data
N/A	Ramp Length (in)	48.5	Yes	Ramp Slope (%)	6.6
No	Ramp Width (in)	46.5	Yes	Ramp XSlope (%)	4.1
N/A	Flare Type LT	N/A	N/A	Flare Type RT	N/A
N/A	Flare Slope LT (%)	N/A	N/A	Flare Slope RT (%)	N/A
N/A	Flare Traversable LT?	N/A	N/A	Flare Traversable RT?	N/A
N/A	Landing Length (in)	N/A	N/A	DWS Provided?	N/A
N/A	Landing Width (in)	N/A	N/A	DWS Contrast?	N/A
N/A	Landing Slope (%)	N/A	N/A	DWS Length (in)	N/A
N/A	Landing X Slope (%)	N/A	N/A	DWS Full Width?	N/A
N/A	Landing Curb? (Y/N)	N/A	N/A	DWS Offset (in)	N/A
N/A	Shared Landing?	N/A			
N/A	Gutter Ponding?	N/A	N/A	Gutter Slope (%)	N/A
N/A	Gutter Lip Ht (in)	N/A	N/A	Gutter X Slope (%)	N/A
N/A	Painted X Walk1?	No	N/A	Painted X Walk2?	N/A
	X Walk 1 Direction	To W		X Walk 2 Direction	N/A
N/A	X Walk 1 Width (in)	N/A	N/A	X Walk 2 Width (in)	N/A
	X Walk 1 Slope (%)	2.8		X Walk 2 Slope (%)	N/A
	X Walk 1 X Slope (%)	4.1		X Walk 2 X Slope (%)	N/A

N/A	Ramp inside XWalk1?	N/A	N/A	Ramp inside XWalk2?	N/A
	Road Slope (%)	N/A	N/A	Clear Space?	N/A
	Road X Slope (%)	N/A	N/A	Clear Space to XWalk (in)	N/A
N/A	Any Obstructions?	N/A	N/A	Storm Grate/Utility Hazard?	N/A
	Obstruction Type			Storm Grate/Utility Type	
		N/A			N/A
			Yes	Surface Condition? (G/P)	Good

**Remove & Replace Entire Ramp.**
