Access Compliance Report

Public Rights-of-Way

(Curb Ramps)

Intersection ID: 7478	Main Street: STONEHURST_DR	Cross Street: SULLINS_RD	Location:	N
ADA ID: 132864B01B59	Ramp Type: Perp	Initial Pass/Fail: Fail	Overall Compliance: No	Severity Score: 1.25
Codes/Mitigation Info/Possible Solution		Field Measurements/Component Compliance

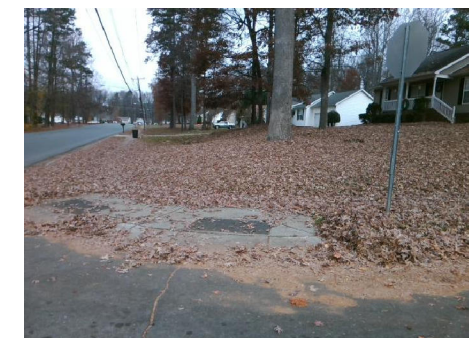
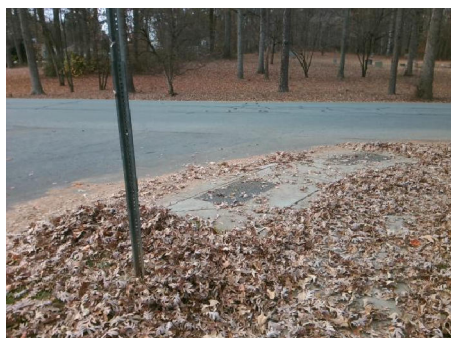
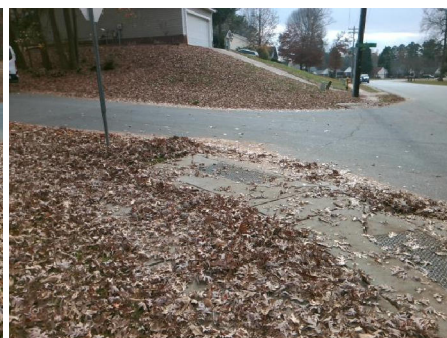
Not Found, R304.5.3

Compliance	Description	Data	Compliance	Description	Data
N/A	Ramp Length (in)	48.5	Yes	Ramp Slope (%)	7.2
Yes	Ramp Width (in)	48.0	No	Ramp XSlope (%)	4.3
N/A	Flare Type LT	N/A	N/A	Flare Type RT	N/A
N/A	Flare Slope LT (%)	N/A	N/A	Flare Slope RT (%)	N/A
N/A	Flare Traversable LT?	N/A	N/A	Flare Traversable RT?	N/A
N/A	Landing Length (in)	N/A	N/A	DWS Provided?	N/A
N/A	Landing Width (in)	N/A	N/A	DWS Contrast?	N/A
N/A	Landing Slope (%)	N/A	N/A	DWS Length (in)	N/A
N/A	Landing X Slope (%)	N/A	N/A	DWS Full Width?	N/A
N/A	Landing Curb? (Y/N)	N/A	N/A	DWS Offset (in)	N/A
N/A	Shared Landing?	N/A			
N/A	Gutter Ponding?	N/A	N/A	Gutter Slope (%)	N/A
N/A	Gutter Lip Ht (in)	N/A	N/A	Gutter X Slope (%)	N/A
N/A	Painted X Walk1?	No	N/A	Painted X Walk2?	N/A
	X Walk 1 Direction	To S		X Walk 2 Direction	N/A
N/A	X Walk 1 Width (in)	N/A	N/A	X Walk 2 Width (in)	N/A
	X Walk 1 Slope (%)	3.5		X Walk 2 Slope (%)	N/A
	X Walk 1 X Slope (%)	5.8		X Walk 2 X Slope (%)	N/A

N/A	Ramp inside XWalk1?	N/A	N/A	Ramp inside XWalk2?	N/A
	Road Slope (%)	N/A	N/A	Clear Space?	N/A
	Road X Slope (%)	N/A	N/A	Clear Space to XWalk (in)	N/A
N/A	Any Obstructions?	N/A	N/A	Storm Grate/Utility Hazard?	N/A
	Obstruction Type			Storm Grate/Utility Type	
		N/A			N/A
			Yes	Surface Condition? (G/P)	Good

Remove & Replace Entire Ramp.
