# Access Compliance Report

## Public Rights-of-Way

### (Curb Ramps)

Intersection ID: 5014	Main Street: CRANBERRY_NOOK_CT	Cross Street: HEDGECREST_PL	Location: E
ADA ID: 1329458755A5	Ramp Type: Perp	Initial Pass/Fail: Fail	Overall Compliance: No
Severity Score: 37.5			
Codes/Mitigation Info/Possible Solution		Field Measurements/Component Compliance

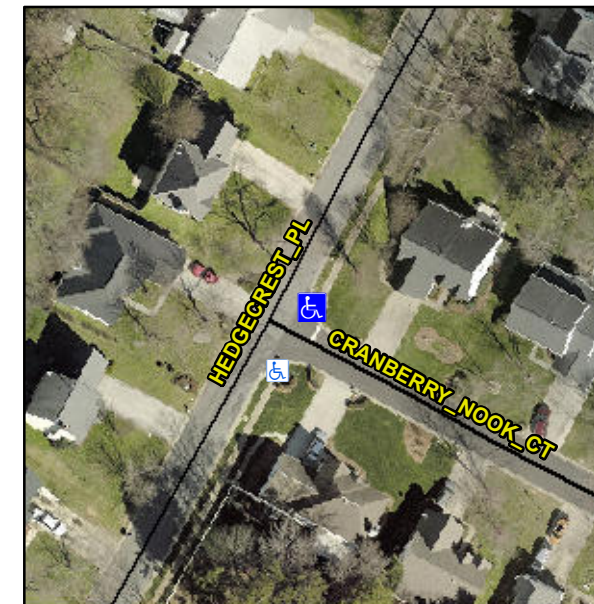
**Not Found, R304.2.2, R304.5.3**

Compliance	Description	Data	Compliance	Description	Data
N/A	Ramp Length (in)	48.0	No	Ramp Slope (%)	12.2
Yes	Ramp Width (in)	48.0	No	Ramp XSlope (%)	6.2
N/A	Flare Type LT	N/A	N/A	Flare Type RT	N/A
N/A	Flare Slope LT (%)	N/A	N/A	Flare Slope RT (%)	N/A
N/A	Flare Traversable LT?	N/A	N/A	Flare Traversable RT?	N/A
N/A	Landing Length (in)	N/A	N/A	DWS Provided?	N/A
N/A	Landing Width (in)	N/A	N/A	DWS Contrast?	N/A
N/A	Landing Slope (%)	N/A	N/A	DWS Length (in)	N/A
N/A	Landing X Slope (%)	N/A	N/A	DWS Full Width?	N/A
N/A	Landing Curb? (Y/N)	N/A	N/A	DWS Offset (in)	N/A
N/A	Shared Landing?	N/A			
N/A	Gutter Ponding?	N/A	N/A	Gutter Slope (%)	N/A
N/A	Gutter Lip Ht (in)	N/A	N/A	Gutter X Slope (%)	N/A
N/A	Painted X Walk1?	No	N/A	Painted X Walk2?	N/A
	X Walk 1 Direction	To SW		X Walk 2 Direction	N/A
N/A	X Walk 1 Width (in)	N/A	N/A	X Walk 2 Width (in)	N/A
	X Walk 1 Slope (%)	0.8		X Walk 2 Slope (%)	N/A
	X Walk 1 X Slope (%)	3.6		X Walk 2 X Slope (%)	N/A

N/A	Ramp inside XWalk1?	N/A	N/A	Ramp inside XWalk2?	N/A
	Road Slope (%)	N/A	N/A	Clear Space?	N/A
	Road X Slope (%)	N/A	N/A	Clear Space to XWalk (in)	N/A
N/A	Any Obstructions?	N/A	N/A	Storm Grate/Utility Hazard?	N/A
	Obstruction Type			Storm Grate/Utility Type	
		N/A			N/A
		Yes		Surface Condition? (G/P)	Good

Possible Solutions:

**Remove & Replace Entire Ramp.**
