Intersection ID: 49653	Main Street: GREENWAY_CRESCENT_LN	Cross Street: E_12TH_ST	Location:	NE
ADA ID: 1329EED84458	Ramp Type: Perp	Initial Pass/Fail: Fail	Overall Compliance: No	Severity Score: 8.75

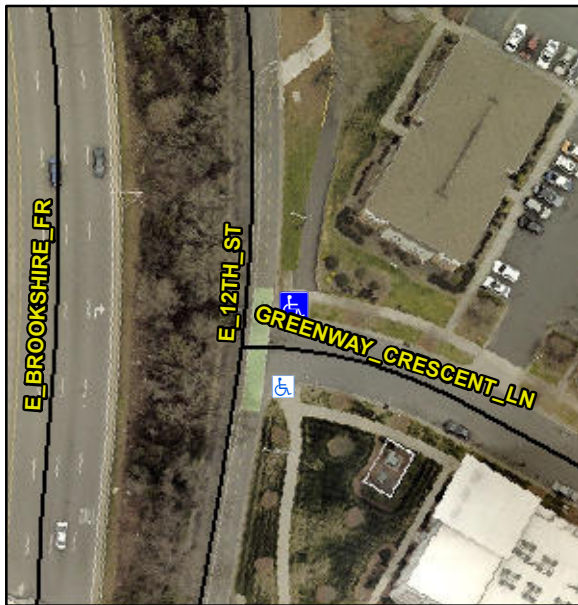
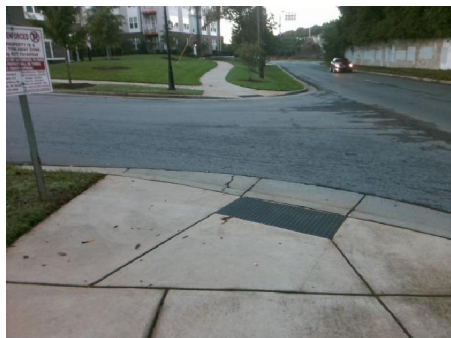
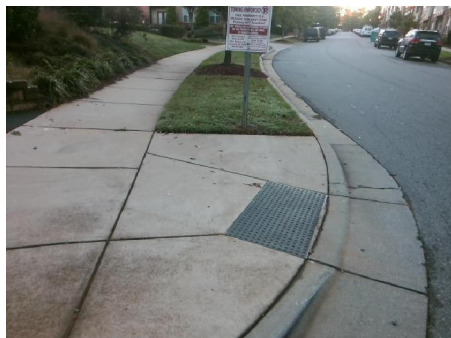
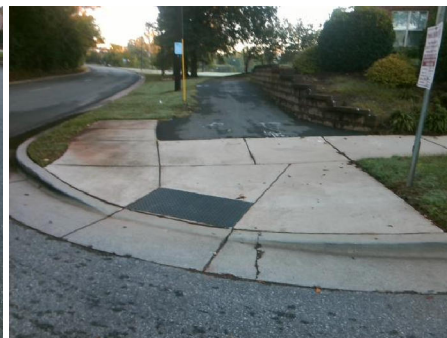
**Not Found, R304.5.1**

Compliance	Description	Data	Compliance	Description	Data
N/A	Ramp Length (in)	60.0	Yes	Ramp Slope (%)	7.6
No	Ramp Width (in)	47.5	Yes	Ramp XSlope (%)	0.4
N/A	Flare Type LT	N/A	N/A	Flare Type RT	N/A
N/A	Flare Slope LT (%)	N/A	N/A	Flare Slope RT (%)	N/A
N/A	Flare Traversable LT?	N/A	N/A	Flare Traversable RT?	N/A
N/A	Landing Length (in)	N/A	N/A	DWS Provided?	N/A
N/A	Landing Width (in)	N/A	N/A	DWS Contrast?	N/A
N/A	Landing Slope (%)	N/A	N/A	DWS Length (in)	N/A
N/A	Landing X Slope (%)	N/A	N/A	DWS Full Width?	N/A
N/A	Landing Curb? (Y/N)	N/A	N/A	DWS Offset (in)	N/A
N/A	Shared Landing?	N/A			
N/A	Gutter Ponding?	N/A	N/A	Gutter Slope (%)	N/A
N/A	Gutter Lip Ht (in)	N/A	N/A	Gutter X Slope (%)	N/A
N/A	Painted X Walk1?	No	N/A	Painted X Walk2?	N/A
	X Walk 1 Direction	To S		X Walk 2 Direction	N/A
N/A	X Walk 1 Width (in)	N/A	N/A	X Walk 2 Width (in)	N/A
	X Walk 1 Slope (%)	0.3		X Walk 2 Slope (%)	N/A
	X Walk 1 X Slope (%)	1.6		X Walk 2 X Slope (%)	N/A

N/A	Ramp inside XWalk1?	N/A	N/A	Ramp inside XWalk2?	N/A
	Road Slope (%)	N/A	N/A	Clear Space?	N/A
	Road X Slope (%)	N/A	N/A	Clear Space to XWalk (in)	N/A
N/A	Any Obstructions?	N/A	N/A	Storm Grate/Utility Hazard?	N/A
	Obstruction Type			Storm Grate/Utility Type	
		N/A			N/A
			Yes	Surface Condition? (G/P)	Good

### Possible Solutions:

### Remove & Replace Entire Ramp.
