# Access Compliance Report

## Public Rights-of-Way

### (Curb Ramps)

Intersection ID: 9202	Main Street: DEWOLFE_ST	Cross Street: GLENWOOD_DR	Location: SW
ADA ID: 132A771462B3	Ramp Type: Para	Initial Pass/Fail: Fail	Overall Compliance: No
Severity Score: 12.5			
Codes/Mitigation Info/Possible Solution		Field Measurements/Component Compliance

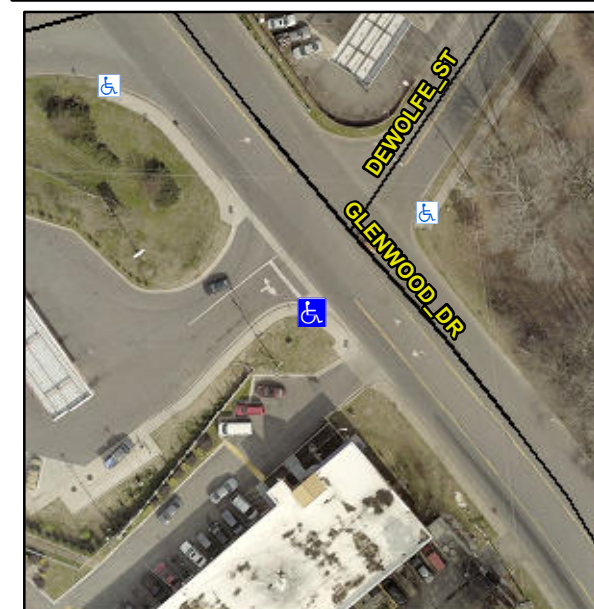
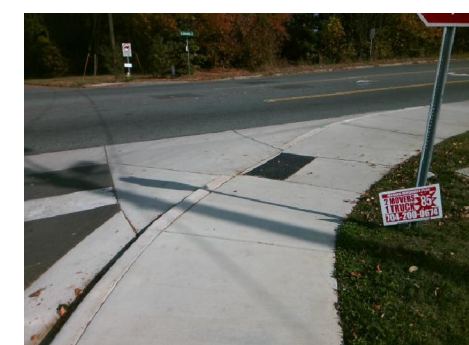
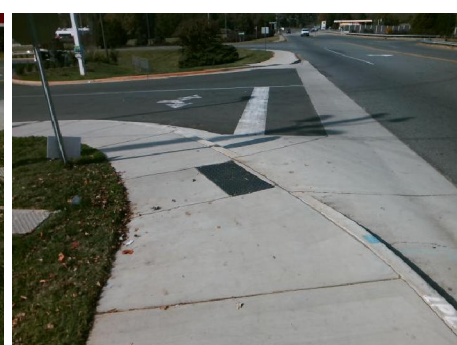
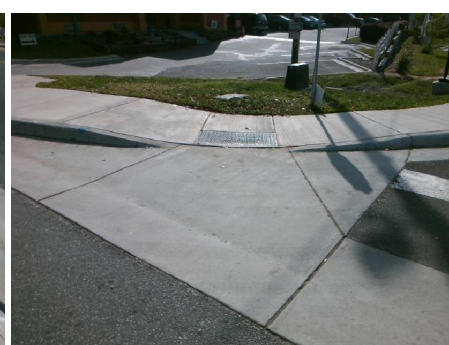
**CURB GAP 1.0, RT RP < 5%**

**R304.3.2**

Compliance	Description	Data	Compliance	Description	Data
N/A	Ramp Length LT (in)	60.0	N/A	Ramp Length RT (in)	59.0
Yes	Ramp Width LT (in)	77.0	Yes	Ramp Width RT (in)	68.0
No	Ramp Slope LT (%)	9.5	Yes	Ramp Slope RT (%)	4.6
Yes	Ramp XSlope LT (%)	1.5	Yes	Ramp XSlope RT (%)	0.7
N/A	Landing Length (in)	N/A	N/A	DWS Provided?	N/A
N/A	Landing Width (in)	N/A	N/A	DWS Contrast?	N/A
N/A	Landing Slope (%)	N/A	N/A	DWS Length (in)	N/A
N/A	Landing X Slope (%)	N/A	N/A	DWS Full Width?	N/A
N/A	Landing Curb? (Y/N)	N/A	N/A	DWS Offset (in)	N/A
N/A	Shared Landing?	N/A			
N/A	Gutter Ponding?	N/A	N/A	Gutter Slope (%)	N/A
N/A	Gutter Lip Ht (in)	N/A	N/A	Gutter X Slope (%)	N/A
N/A	Painted X Walk1?	No	N/A	Painted X Walk2?	N/A
	X Walk 1 Direction	To NE		X Walk 2 Direction	N/A
N/A	X Walk 1 Width (in)	N/A	N/A	X Walk 2 Width (in)	N/A
	X Walk 1 Slope (%)	3.1		X Walk 2 Slope (%)	N/A
	X Walk 1 X Slope (%)	2.9		X Walk 2 X Slope (%)	N/A
N/A	Ramp inside XWalk1?	N/A	N/A	Ramp inside XWalk2?	N/A

**Remove & Replace Entire Ramp.**
