Access Compliance Report

Public Rights-of-Way

(Curb Ramps)

| Intersection ID: 18797 | Main Street: SENECA_PL | Cross Street: WEDGEWOOD_DR | Location: NE |

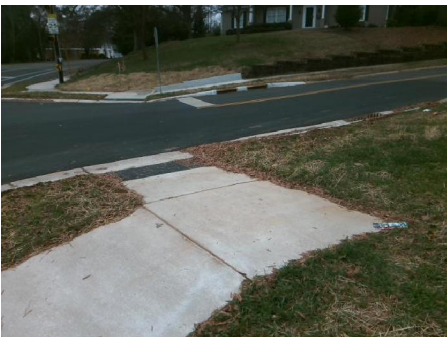
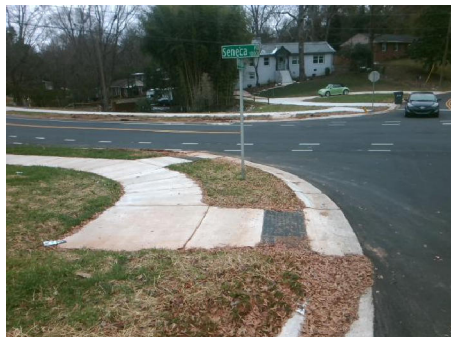
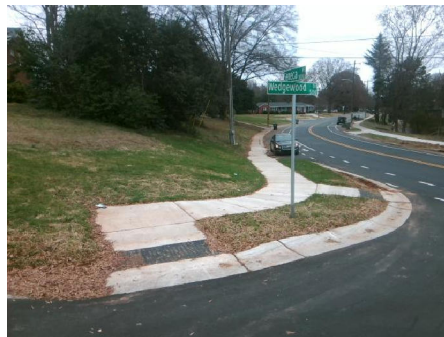
| ADA ID: 1331C0DECF12 | Ramp Type: BlendTrans1 | Initial Pass/Fail: Fail | Overall Compliance: No |

| Compliance | Description | Data | Compliance | Description | Data |
|---|---|---|---|---|---|
| Yes | Ramp Width (in) | 72.0 | No | BlendTrans XSlope (%) | 5.2 |

Remove & Replace Curb Ramp With Two New Directional Ramps or Equivalent.
