Access Compliance Report

Public Rights-of-Way

(Curb Ramps)

| Intersection ID: 52590 | Main Street: NOBLES_AV | Cross Street: TRIUMPH_DR | Location: SW |

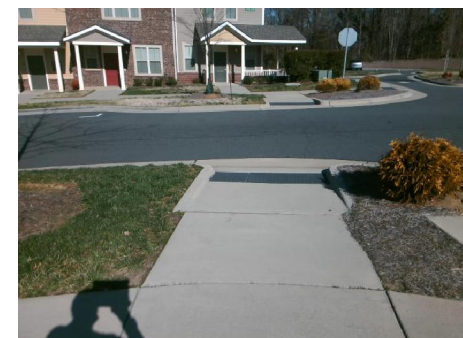
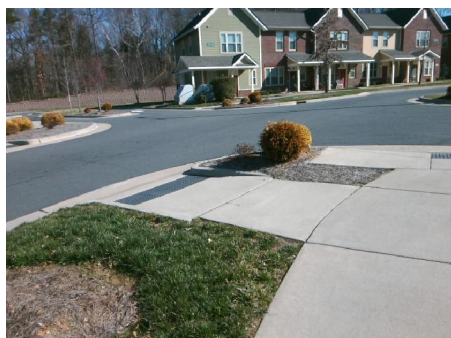
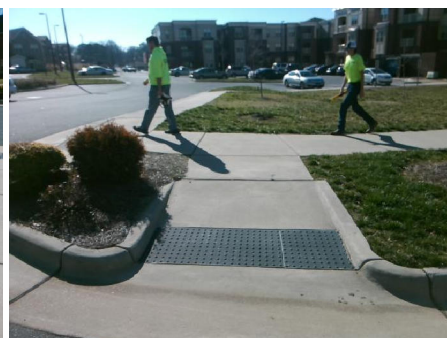
| ADA ID: 133234A7532A | Ramp Type: Perp | Initial Pass/Fail: Fail | Overall Compliance: No |

Not Found, R304.5.3

| Compliance | Description | Data | Compliance | Description | Data |
|---|---|---|---|---|---|
| Yes | Ramp Width (in) | 70.0 | No | Ramp XSlope (%) | 6.3 |

Remove & Replace Entire Ramp.
