Access Compliance Report

Public Rights-of-Way

(Curb Ramps)

Intersection ID: 10024218	Main Street: COVENTRY COURT LN	Cross Street: N/A	Location: S
ADA ID: 13345B87E124	Ramp Type: Perp	Initial Pass/Fail: Pass	Overall Compliance: No
Severity Score: 5			
Codes/Mitigation Info/Possible Solution		Field Measurements/Component Compliance

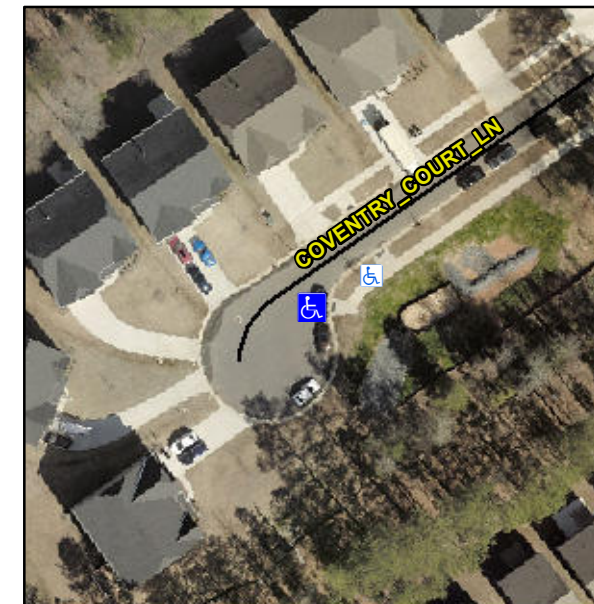
Compliance	Description	Data	Compliance	Description	Data
N/A	Ramp Length (in)	26.0	Yes	Ramp Slope (%)	5.2
Yes	Ramp Width (in)	60.0	Yes	Ramp XSlope (%)	1.4
N/A	Flare Type LT	Sloped	N/A	Flare Type RT	N/A
N/A	Flare Slope LT (%)	3.3	Yes	Flare Slope RT (%)	7.9
N/A	Flare Traversable LT?	Yes	N/A	Flare Traversable RT?	Yes
Yes	Landing Length (in)	70.5	Yes	DWS Provided?	Yes
Yes	Landing Width (in)	60.0	Yes	DWS Contrast?	Yes
Yes	Landing Slope (%)	1.8	Yes	DWS Length (in)	24.0
Yes	Landing X Slope (%)	1.1	Yes	DWS Full Width?	Yes
N/A	Landing Curb? (Y/N)	No	Yes	DWS Offset (in)	2.0
N/A	Shared Landing?	No			
Yes	Gutter Ponding?	No	No	Gutter Slope (%)	10.5
Yes	Gutter Lip Ht (in)	0.0	Yes	Gutter X Slope (%)	1.2
N/A	Painted X Walk1?	No	N/A	Painted X Walk2?	N/A
	X Walk 1 Direction	To W		X Walk 2 Direction	N/A
N/A	X Walk 1 Width (in)	N/A	N/A	X Walk 2 Width (in)	N/A
	X Walk 1 Slope (%)	3.5		X Walk 2 Slope (%)	N/A
	X Walk 1 X Slope (%)	1.1		X Walk 2 X Slope (%)	N/A

N/A	Ramp inside XWalk1?	N/A	N/A	Ramp inside XWalk2?	N/A
	Road Slope (%)	N/A	N/A	Clear Space?	Yes
	Road X Slope (%)	N/A	N/A	Clear Space to XWalk (in)	N/A
Yes	Any Obstructions?	No	Yes	Storm Grate/Utility Hazard?	No
	Obstruction Type			Storm Grate/Utility Type	
		N/A			N/A
			Yes	Surface Condition? (G/P)	Good

Possible Solutions:

Remove & Replace Gutter.

R304.5.4
