Access Compliance Report

Public Rights-of-Way

(Curb Ramps)

Intersection ID: 11603	Main Street: AVENTIDE_LN	Cross Street: SERENADE_CT	Location: SE
ADA ID: 133B0E80D5D1	Ramp Type: BlendTrans1	Initial Pass/Fail: Fail	Overall Compliance: No
Severity Score: 1.25			
Codes/Mitigation Info/Possible Solution		Field Measurements/Component Compliance

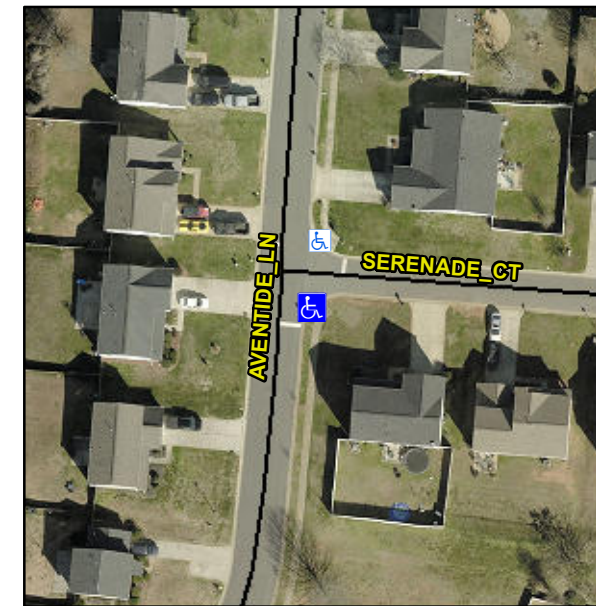
Not Found, R304.5.3

Compliance	Description	Data	Compliance	Description	Data
N/A	Ramp Length (in)	50.0	Yes	BlendTrans Slope (%)	4.2
Yes	Ramp Width (in)	48.0	No	BlendTrans XSlope (%)	3.2
N/A	Flare Type LT	N/A	N/A	Flare Type RT	N/A
N/A	Flare Slope LT (%)	N/A	N/A	Flare Slope RT (%)	N/A
N/A	Flare Traversable LT?	N/A	N/A	Flare Traversable RT?	N/A
N/A	Landing Length (in)	N/A	N/A	DWS Provided?	N/A
N/A	Landing Width (in)	N/A	N/A	DWS Contrast?	N/A
N/A	Landing Slope (%)	N/A	N/A	DWS Length (in)	N/A
N/A	Landing X Slope (%)	N/A	N/A	DWS Full Width?	N/A
N/A	Landing Curb? (Y/N)	N/A	N/A	DWS Offset (in)	N/A
N/A	Shared Landing?	N/A			
N/A	Gutter Ponding?	N/A	N/A	Gutter Slope (%)	N/A
N/A	Gutter Lip Ht (in)	N/A	N/A	Gutter X Slope (%)	N/A
N/A	Painted X Walk1?	No	N/A	Painted X Walk2?	N/A
	X Walk 1 Direction	To N		X Walk 2 Direction	N/A
	X Walk 1 Width (in)	N/A		X Walk 2 Width (in)	N/A
	X Walk 1 Slope (%)	4.6		X Walk 2 Slope (%)	N/A
	X Walk 1 X Slope (%)	2.1		X Walk 2 X Slope (%)	N/A

N/A	Ramp inside XWalk1?	N/A	N/A	Ramp inside XWalk2?	N/A
	Road Slope (%)	2.1		Clear Space?	N/A
	Road X Slope (%)	4.6	N/A	Clear Space to XWalk (in)	N/A
N/A	Any Obstructions?	N/A	N/A	Storm Grate/Utility Hazard?	N/A
	Obstruction Type			Storm Grate/Utility Type	
		N/A			N/A
			Yes	Surface Condition? (G/P)	Good
			No	Curb Slope (%)	16.3

Remove & Replace Curb Ramp With Two New Directional Ramps or Equivalent.
