Access Compliance Report Public Rights-of-Way (Curb Ramps)

Intersection ID: 21296 Main Street: E_ARROWOOD_RD Cross Street: ENGLAND_ST Location: SE

ADA ID: 134DD97C2D7B Ramp Type: Directional1 Initial Pass/Fail: Fail Overall Compliance: No Severity Score: 13.75

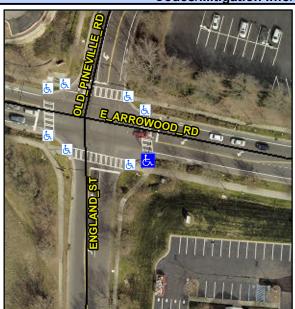
russible solution			i leid Measurements/Component Compilance				
Possible Solutions:		Compliance Description		Data	Data Compliance Description		
Remove & Replace Enti	re Rar	mp.	N/A	Ramp Length (in)	84.0	N/A	Grade Break?

•	Yes	Ramp Width (in)	73.0	N/A	Grade Break Slope (%)
			No	Ramp Slope (%)	10.5	N/A	Grade Break XSlope (%)
			No	Ramp XSlope (%)	2.2		
			N/A	Flare Type LT	N/A	N/A	Flare Type RT
			N/A	Flare Slope LT (%)	N/A	N/A	Flare Slope RT (%)
Surveyor Notes:			N/A	Flare Traversable LT?	N/A	N/A	Flare Traversable RT?
N/A			N/A	Landing Length (in)	0.0	N/A	DWS Provided?
			N/A	Landing Width (in)	0.0	N/A	DWS Contrast?
			N/A	Landing Slope (%)	0.0	N/A	DWS Length (in)
			N/A	Landing X Slope (%)	0.0	N/A	DWS Full Width?
PROW/ADA:			N/A	Landing Curb? (Y/N)	N/A	N/A	DWS Offset LT (in)
R304.2.2, R304.5.3			N/A	Shared Landing?	N/A	N/A	DWS Offset RT (in)
