# Access Compliance Report

## Public Rights-of-Way

### (Curb Ramps)

Intersection ID: 14482	Main Street: WALLACE_AV	Cross Street: WALLACE_GLEN_DR	Location: NE
ADA ID: 135BD6CD0CF1	Ramp Type: PerpDiag	Initial Pass/Fail: Fail	Overall Compliance: No
		Severity Score: 22.5

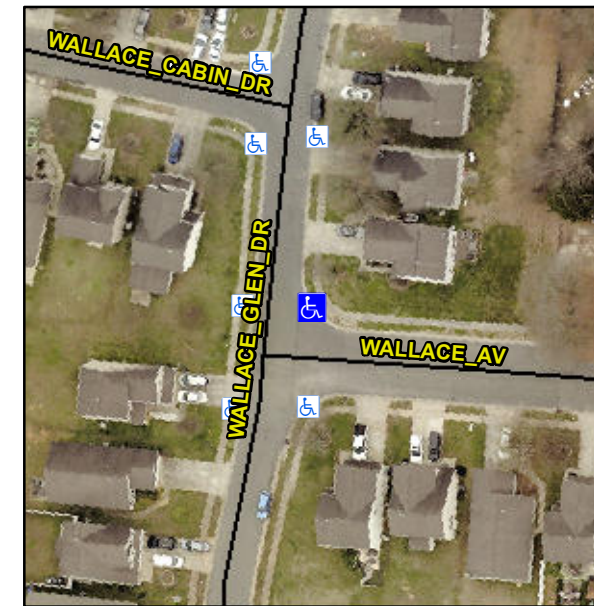
Compliance	Description	Data	Compliance	Description	Data
N/A	Ramp Length (in)	49.5	No	Ramp Slope (%)	8.5
No	Ramp Width (in)	41.0	No	Ramp XSlope (%)	2.1
N/A	Flare Type LT	N/A	N/A	Flare Type RT	N/A
N/A	Flare Slope LT (%)	N/A	N/A	Flare Slope RT (%)	N/A
N/A	Flare Traversable LT?	N/A	N/A	Flare Traversable RT?	N/A
N/A	Landing Length (in)	N/A	N/A	DWS Provided?	N/A
N/A	Landing Width (in)	N/A	N/A	DWS Contrast?	N/A
N/A	Landing Slope (%)	N/A	N/A	DWS Length (in)	N/A
N/A	Landing X Slope (%)	N/A	N/A	DWS Full Width?	N/A
N/A	Landing Curb? (Y/N)	N/A	N/A	DWS Offset (in)	N/A
N/A	Shared Landing?	N/A			
N/A	Gutter Ponding?	N/A	N/A	Gutter Slope (%)	N/A
N/A	Gutter Lip Ht (in)	0.5	N/A	Gutter X Slope (%)	N/A
N/A	Painted X Walk1?	No	N/A	Painted X Walk2?	No
	X Walk 1 Direction	To W		X Walk 2 Direction	To S
N/A	X Walk 1 Width (in)	N/A	N/A	X Walk 2 Width (in)	N/A
	X Walk 1 Slope (%)	0.6		X Walk 2 Slope (%)	0.9
	X Walk 1 X Slope (%)	1.2		X Walk 2 X Slope (%)	0.3

N/A	Ramp inside XWalk1?	N/A	N/A	Ramp inside XWalk2?	N/A
	Road Slope (%)	0.3	N/A	Clear Space?	N/A
	Road X Slope (%)	2.0	N/A	Clear Space to XWalk (in)	N/A
N/A	Any Obstructions?	N/A	N/A	Storm Grate/Utility Hazard?	N/A
	Obstruction Type			Storm Grate/Utility Type	
		N/A			N/A
			Yes	Surface Condition? (G/P)	Good

**Remove & Replace Curb Ramp With Two New Directional Ramps or Equivalent.**

**R304.5.1, R304.2.2, R304.5.3**

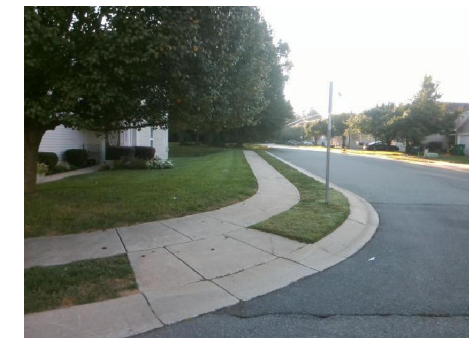
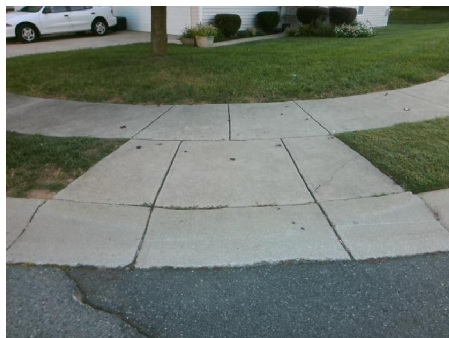
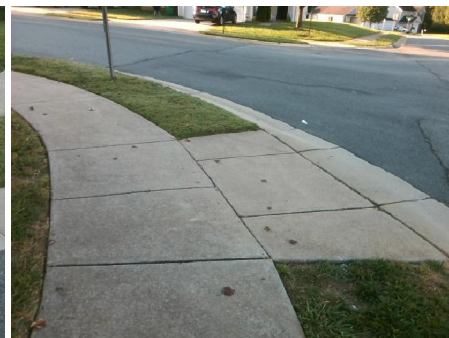
Street 1 Name **WALLACE GLEN DR**  
 Stop Condition-Street 2 **None**  
 Street 2 Name **WALLACE AV**  
 Stop Condition-Street 1 **StopSign**
