# Access Compliance Report

## Public Rights-of-Way

### (Curb Ramps)

| Intersection ID: 30301 | Main Street: BLACK_KETTLE_DR | Cross Street: SHINKANSEN_DR | Location: W |

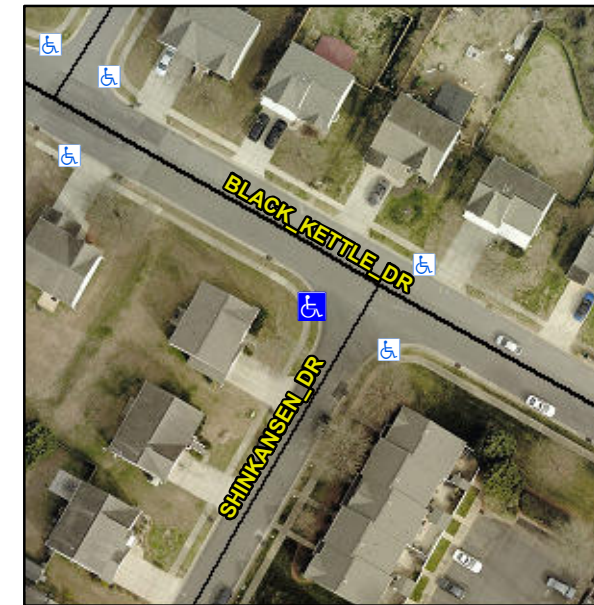
**CURB LIP 0.5**

**Not Found, R304.5.3**

| Compliance | Description | Data | Compliance | Description | Data |
|---|---|---|---|---|---|
| Yes | Ramp Width (in) | 48.0 | No | BlendTrans XSlope (%) | 5.2 |
| | | | No | Curb Slope (%) | 5.5 |

**Remove & Replace Curb Ramp With Two New Directional Ramps or Equivalent.**

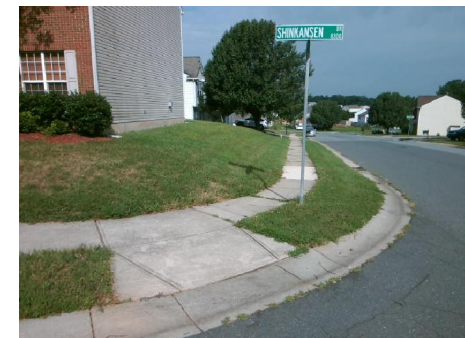
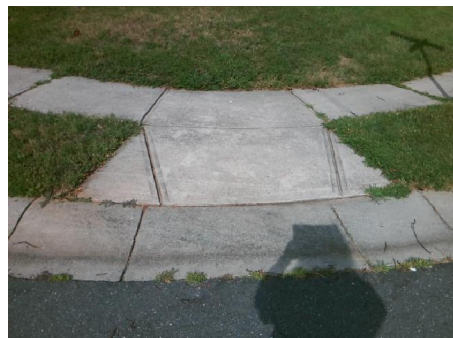
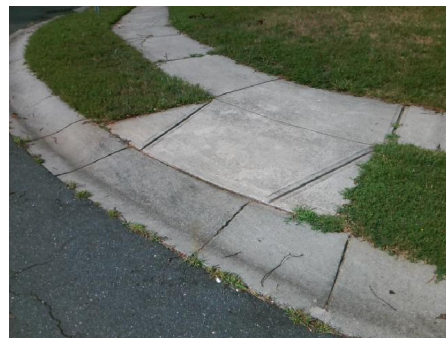
Street 1 Name SHINKANSEN DR  
 Stop Condition-Street 1 StopSign  
 Street 2 Name BLACK KETTLE DR  
 Stop Condition-Street 2 None
