Access Compliance Report

Public Rights-of-Way

(Curb Ramps)

Intersection ID: 6473	Main Street: MINERAL_SPRINGS_RD	Cross Street: N_GRAHAM_ST	Location: S
ADA ID: 1378FD54E245	Ramp Type: Para	Initial Pass/Fail: Fail	Overall Compliance: No
Codes/Mitigation Info/Possible Solution		Field Measurements/Component Compliance	
Severity Score: 16.25

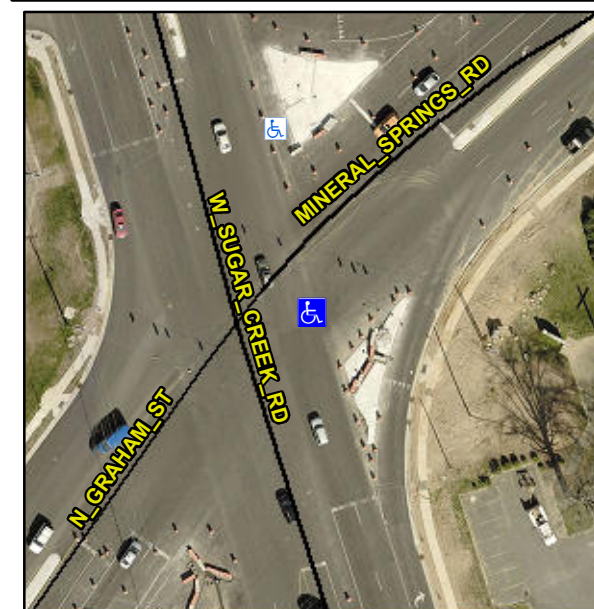
LT RP < 5%

R304.5.3, R302.7

Compliance	Description	Data	Compliance	Description	Data
N/A	Ramp Length LT (in)	82.0	N/A	Ramp Length RT (in)	64.0
Yes	Ramp Width LT (in)	94.0	Yes	Ramp Width RT (in)	59.0
Yes	Ramp Slope LT (%)	2.1	Yes	Ramp Slope RT (%)	5.6
No	Ramp XSlope LT (%)	3.7	No	Ramp XSlope RT (%)	3.4
N/A	Landing Length (in)	N/A	N/A	DWS Provided?	N/A
N/A	Landing Width (in)	N/A	N/A	DWS Contrast?	N/A
N/A	Landing Slope (%)	N/A	N/A	DWS Length (in)	N/A
N/A	Landing X Slope (%)	N/A	N/A	DWS Full Width?	N/A
N/A	Landing Curb? (Y/N)	N/A	N/A	DWS Offset (in)	N/A
N/A	Shared Landing?	N/A			
N/A	Gutter Ponding?	N/A	N/A	Gutter Slope (%)	N/A
N/A	Gutter Lip Ht (in)	N/A	N/A	Gutter X Slope (%)	N/A
N/A	Painted X Walk1?	No	N/A	Painted X Walk2?	N/A
	X Walk 1 Direction	To N		X Walk 2 Direction	N/A
N/A	X Walk 1 Width (in)	N/A	N/A	X Walk 2 Width (in)	N/A
	X Walk 1 Slope (%)	0.4		X Walk 2 Slope (%)	N/A
	X Walk 1 X Slope (%)	2.2		X Walk 2 X Slope (%)	N/A
N/A	Ramp inside XWalk1?	N/A	N/A	Ramp inside XWalk2?	N/A

Road Slope (%)	N/A	N/A	Clear Space?	N/A
	Road X Slope (%)	N/A	N/A	Clear Space to XWalk (in)	N/A
N/A	Any Obstructions?	N/A	N/A	Storm Grate/Utility Hazard?	N/A
	Obstruction Type			Storm Grate/Utility Type	
		N/A			N/A
			No	Surface Condition? (G/P)	Poor
			N/A	Curb Slope (%)	N/A

Possible Solutions:

Remove & Replace Entire Ramp.
