Access Compliance Report

Public Rights-of-Way

(Curb Ramps)

Intersection ID: 45498	Main Street: COTTON_PRESS_RD	Cross Street: GRASSY_CROPS_RD	Location: E
ADA ID: 137F6D0EC738	Ramp Type: Perp	Initial Pass/Fail: Fail	Overall Compliance: No
Severity Score: 12.5			
Codes/Mitigation Info/Possible Solution		Field Measurements/Component Compliance

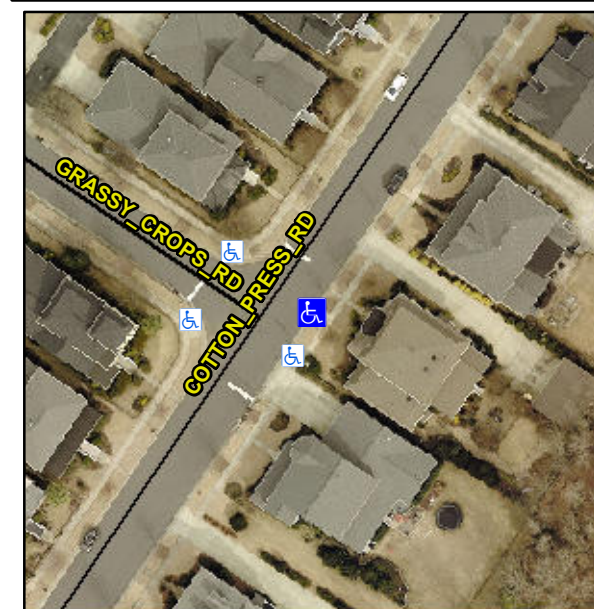
Not Found, R304.2.2

Compliance	Description	Data	Compliance	Description	Data
N/A	Ramp Length (in)	72.0	No	Ramp Slope (%)	9.7
Yes	Ramp Width (in)	48.0	Yes	Ramp XSlope (%)	0.7
N/A	Flare Type LT	N/A	N/A	Flare Type RT	N/A
N/A	Flare Slope LT (%)	N/A	N/A	Flare Slope RT (%)	N/A
N/A	Flare Traversable LT?	N/A	N/A	Flare Traversable RT?	N/A
N/A	Landing Length (in)	N/A	N/A	DWS Provided?	N/A
N/A	Landing Width (in)	N/A	N/A	DWS Contrast?	N/A
N/A	Landing Slope (%)	N/A	N/A	DWS Length (in)	N/A
N/A	Landing X Slope (%)	N/A	N/A	DWS Full Width?	N/A
N/A	Landing Curb? (Y/N)	N/A	N/A	DWS Offset (in)	N/A
N/A	Shared Landing?	N/A			
N/A	Gutter Ponding?	N/A	N/A	Gutter Slope (%)	N/A
N/A	Gutter Lip Ht (in)	N/A	N/A	Gutter X Slope (%)	N/A
N/A	Painted X Walk1?	No	N/A	Painted X Walk2?	N/A
	X Walk 1 Direction	To NW		X Walk 2 Direction	N/A
N/A	X Walk 1 Width (in)	N/A	N/A	X Walk 2 Width (in)	N/A
	X Walk 1 Slope (%)	1.0		X Walk 2 Slope (%)	N/A
	X Walk 1 X Slope (%)	0.9		X Walk 2 X Slope (%)	N/A

Possible Solutions:

Remove & Replace Entire Ramp.

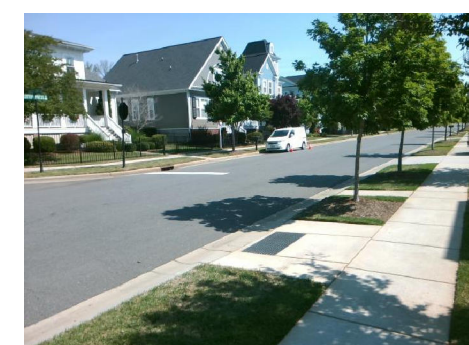
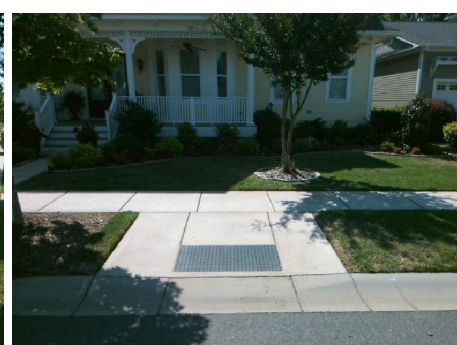
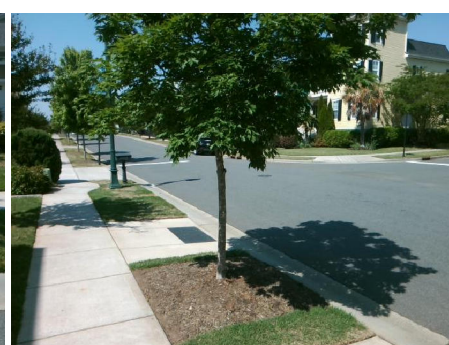
N/A	Ramp inside XWalk1?	N/A	N/A	Ramp inside XWalk2?	N/A
	Road Slope (%)	N/A	N/A	Clear Space?	N/A
	Road X Slope (%)	N/A	N/A	Clear Space to XWalk (in)	N/A
N/A	Any Obstructions?	N/A	N/A	Storm Grate/Utility Hazard?	N/A
	Obstruction Type			Storm Grate/Utility Type	
		N/A			N/A
			Yes	Surface Condition? (G/P)	Good
