Access Compliance Report Public Rights-of-Way (Curb Ramps)

Intersection ID: 13118 Main Street: E_7TH_ST Cross Street: CENTRAL_AV Location:

Overall Compliance: No ADA ID: 1395B4F203D7 Ramp Type: BlendTrans1 Initial Pass/Fail: Fail **Severity Score:** 8.75

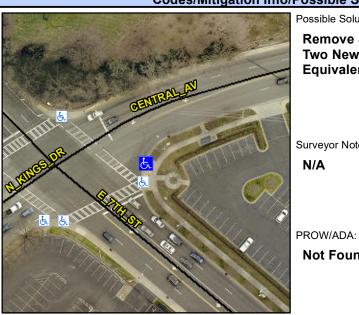
Not Found, R304.5.1

Field Measurements/Component Compliance								
Compli	ance Description	Data	Compli	ance Description	Data			
N/A	Ramp Length (in)	96.0	Yes	BlendTrans Slope (%)	3.2			
No	Ramp Width (in)	46.0	Yes	BlendTrans XSlope (%)	0.8			
N/A	Flare Type LT	N/A	N/A	Flare Type RT	N/A			
N/A	Flare Slope LT (%)	N/A	N/A	Flare Slope RT (%)	N/A			
N/A	Flare Traversable LT?	N/A	N/A	Flare Traversable RT?	N/A			
N/A	Landing Length (in)	N/A	N/A	DWS Provided?	N/A			
N/A	Landing Width (in)	N/A	N/A	DWS Contrast?	N/A			
N/A	Landing Slope (%)	N/A	N/A	DWS Length (in)	N/A			
N/A	Landing X Slope (%)	N/A	N/A	DWS Full Width?	N/A			
N/A	Landing Curb? (Y/N)	N/A	N/A	DWS Offset (in)	N/A			
N/A	Shared Landing?	N/A						
N/A	Gutter Ponding?	Yes	N/A	Gutter Slope (%)	N/A			
N/A	Gutter Lip Ht (in)	N/A	N/A	Gutter X Slope (%)	N/A			
N/A	Painted X Walk1?	Yes	N/A	Painted X Walk2?	N/A			
	X Walk 1 Direction	To NW		X Walk 2 Direction	N/A			
	X Walk 1 Width (in)	110.0		X Walk 2 Width (in)	N/A

X Walk 1 Slope (%)	0.5		X Walk 2 Slope (%)	N/A			
	X Walk 1 X Slope (%)	2.1		X Walk 2 X Slope (%)	N/A			
N/A	Ramp inside XWalk1?	Yes	N/A	Ramp inside XWalk2?	N/A			
	Road Slope (%)	2.1		Clear Space?	N/A			
	Road X Slope (%)	0.5	N/A	Clear Space to XWalk (in)	N/A			
N/A	Any Obstructions?	N/A	N/A	Storm Grate/Utility Hazard?	N/A			
	Obstruction Type			Storm Grate/Utility Type				
		N/A			N/A			
			Yes	Surface Condition? (G/P)	Good			
			No	Curb Slope (%)	11.4

Remove & Replace Curb Ramp With **Two New Directional Ramps or** Equivalent.
