Access Compliance Report Public Rights-of-Way (Curb Ramps)

Intersection ID: 3097Main Street: PLACER_MAPLE_LNCross Street: ALLEN_A_BROWN_RDLocation: NWADA ID: 13A45B809F58Ramp Type: PerpDiagInitial Pass/Fail: Fail Overall Compliance: No Severity Score: 10

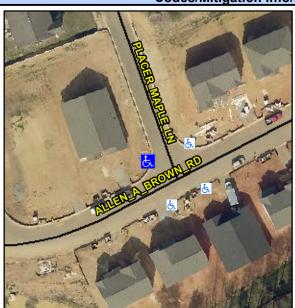
Not Found, R304.5.1, R304.5.3

Compliance Description		Data	Comp	liance	Description	Data
N/A	Ramp Length (in)	50.0	Yes	Ram	Slope (%)	7.8
No	Ramp Width (in)	47.0	No	Ramp XSlope (%)		4.0
N/A	Flare Type LT	N/A	N/A	Flare Type RT		N/A
N/A	Flare Slope LT (%)	N/A	N/A	Flare	Slope RT (%)	N/A
N/A	Flare Traversable LT?	N/A	N/A	Flare	Traversable RT?	N/A
N/A	Landing Length (in)	N/A	N/A	DWS	Provided?	N/A
N/A	Landing Width (in)	N/A	N/A	DWS	Contrast?	N/A
N/A	Landing Slope (%)	N/A	N/A	DWS	Length (in)	N/A
N/A	Landing X Slope (%)	N/A	N/A	DWS	Full Width?	N/A
N/A	Landing Curb? (Y/N)	N/A	N/A	DWS	Offset (in)	N/A
N/A	Shared Landing?	N/A				
N/A	Gutter Ponding?	N/A	N/A	Gutte	er Slope (%)	N/A
N/A	Gutter Lip Ht (in)	1.0	N/A	Gutte	r X Slope (%)	N/A
N/A	Painted X Walk1?	No	N/A	Paint	ed X Walk2?	No
	X Walk 1 Direction	To S		X Wa	lk 2 Direction	To E
N/A	X Walk 1 Width (in)	N/A	N/A	X Wa	lk 2 Width (in)	N/A
	X Walk 1 Slope (%)	0.8		X Wa	lk 2 Slope (%)	6.9
	X Walk 1 X Slope (%)	6.6		X Wa	lk 2 X Slope (%)	0.9

N/A	Ramp inside XWalk1?	N/A	N/A	Ramı	inside XWalk2?	N/A
	Road Slope (%)	4.9	N/A	Clear	Space?	N/A
	Road X Slope (%)	5.4	N/A	Clear	Space to XWalk (in)	N/A
N/A	Any Obstructions?	N/A	N/A	Storn	n Grate/Utility Hazard?	N/A
	Obstruction Type			Storn	n Grate/Utility Type	
		N/A				N/A
			Yes	Surfa	ce Condition? (G/P)	Good

ALLEN A BROWN RD None PLACER MAPLE LN StopSign Possible Solutions:

Remove & Replace Curb Ramp With
Two New Directional Ramps or
Equivalent.

Total Cost: \$ 3200.00
