Access Compliance Report

Public Rights-of-Way

(Curb Ramps)

Intersection ID: 19242	Main Street: SHARON_LN	Cross Street: SHARON_RD	Location: SE
ADA ID: 13AA89954B47	Ramp Type: Para	Initial Pass/Fail: Fail	Overall Compliance: No
Codes/Mitigation Info/Possible Solution			Severity Score: 25
			Field Measurements/Component Compliance

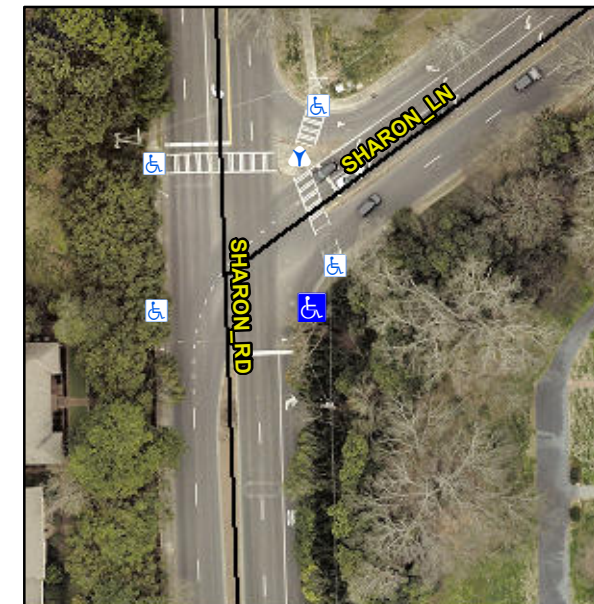
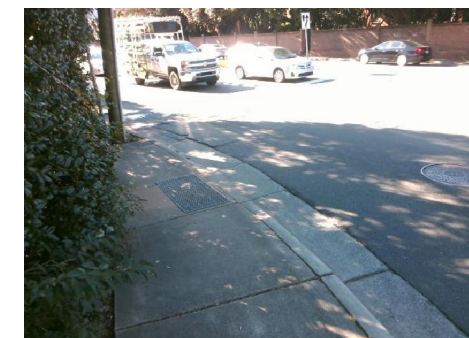
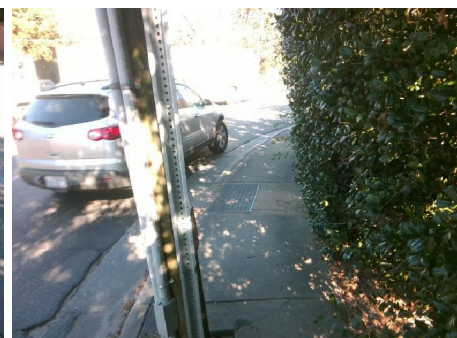
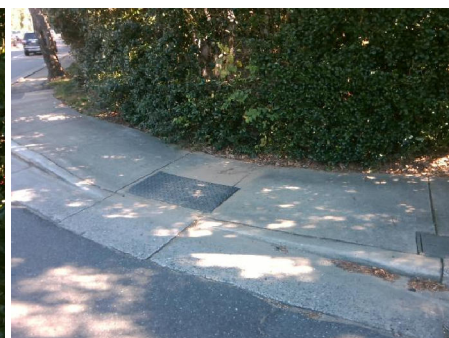
Compliance	Description	Data	Compliance	Description	Data
N/A	Ramp Length LT (in)	66.0	N/A	Ramp Length RT (in)	80.0
Yes	Ramp Width LT (in)	60.0	Yes	Ramp Width RT (in)	60.0
No	Ramp Slope LT (%)	12.3	Yes	Ramp Slope RT (%)	5.8
Yes	Ramp XSlope LT (%)	0.1	Yes	Ramp XSlope RT (%)	1.3
N/A	Landing Length (in)	N/A	N/A	DWS Provided?	N/A
N/A	Landing Width (in)	N/A	N/A	DWS Contrast?	N/A
N/A	Landing Slope (%)	N/A	N/A	DWS Length (in)	N/A
N/A	Landing X Slope (%)	N/A	N/A	DWS Full Width?	N/A
N/A	Landing Curb? (Y/N)	N/A	N/A	DWS Offset (in)	N/A
N/A	Shared Landing?	N/A			
N/A	Gutter Ponding?	N/A	N/A	Gutter Slope (%)	N/A
N/A	Gutter Lip Ht (in)	N/A	N/A	Gutter X Slope (%)	N/A
N/A	Painted X Walk1?	No	N/A	Painted X Walk2?	N/A
	X Walk 1 Direction	To W		X Walk 2 Direction	N/A
N/A	X Walk 1 Width (in)	N/A	N/A	X Walk 2 Width (in)	N/A
	X Walk 1 Slope (%)	0.3		X Walk 2 Slope (%)	N/A
	X Walk 1 X Slope (%)	0.6		X Walk 2 X Slope (%)	N/A
N/A	Ramp inside XWalk1?	N/A	N/A	Ramp inside XWalk2?	N/A

Road Slope (%)	N/A	N/A	Clear Space?	N/A
	Road X Slope (%)	N/A	N/A	Clear Space to XWalk (in)	N/A
N/A	Any Obstructions?	N/A	N/A	Storm Grate/Utility Hazard?	N/A
	Obstruction Type			Storm Grate/Utility Type	
		N/A			N/A
			Yes	Surface Condition? (G/P)	Good
			N/A	Curb Slope (%)	0.3

Possible Solutions:

Remove & Replace Entire Ramp.

R304.3.2
