# Access Compliance Report

## Public Rights-of-Way

### (Curb Ramps)

| Intersection ID: 53349 | Main Street: SAPPHIRE_HILL_LN | Cross Street: N/A | Location: SE |

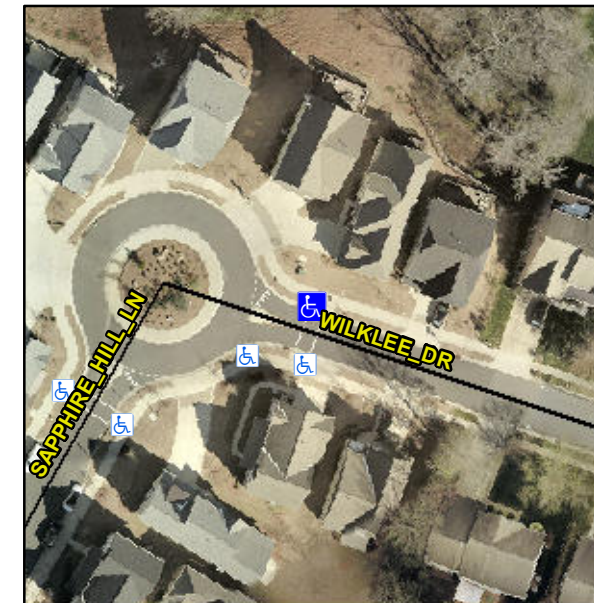
**R304.2.2-Perp, R304.3.2-Para,  
R304.5.4, R304.5.3**

| Compliance | Description | Data | Compliance | Description | Data |
|---|---|---|---|---|---|
| No | Landing Slope (%) | 2.1 | Yes | DWS Length (in) | 24.0 |
| Yes | Gutter Ponding? | No | No | Gutter Slope (%) | 5.3 |
| Yes | Gutter Lip Ht (in) | 0.0 | No | Gutter X Slope (%) | 2.3 |

**Remove & Replace Landing.**  
**Remove & Replace Gutter.**
