# Access Compliance Report

## Public Rights-of-Way

### (Curb Ramps)

| Intersection ID: 9328 | Main Street: PLAZA_LN | Cross Street: THE_PLAZA | Location: S |

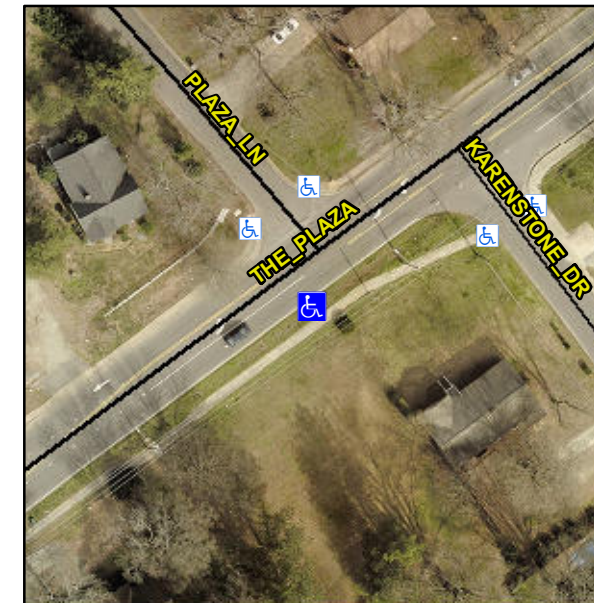
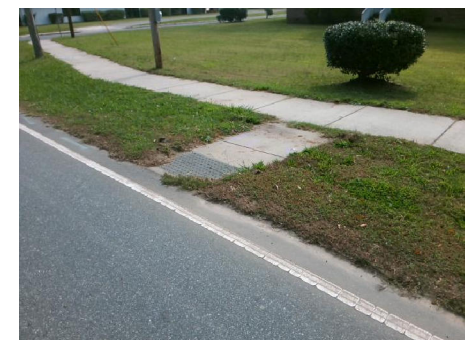
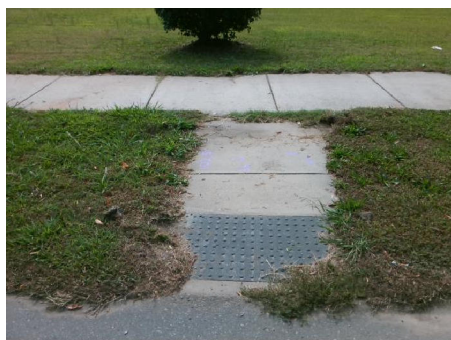
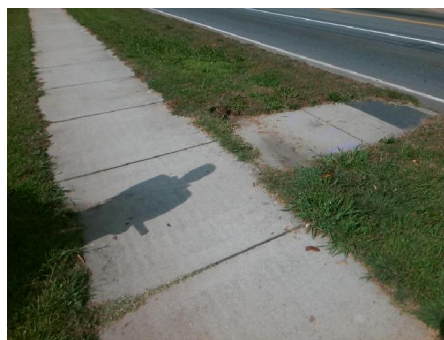
**NO CURB**

| Compliance | Description | Data | Compliance | Description | Data |
|---|---|---|---|---|---|
| No | Landing Slope (%) | 3.5 | Yes | DWS Length (in) | 24.0 |
| N/A | Landing Curb? (Y/N) | No | No | DWS Offset (in) | 5.0 |
| No | Gutter Lip Ht (in) | 1.0 | Yes | Gutter X Slope (%) | 0.8 |

**Remove & Replace Curb Ramp With Two New Directional Ramps or Equivalent. Grind Gutter Lip.**

**R304.2.2-Perp, R304.3.2-Para, R305.2, R302.7.2**
