Access Compliance Report

Public Rights-of-Way

(Curb Ramps)

Intersection ID: 30443	Main Street: CADES_COVE_DR	Cross Street: ELM_BEND_DR	Location: E
ADA ID: 13B67D609F16	Ramp Type: PerpDiag	Initial Pass/Fail: Fail	Overall Compliance: No
Severity Score: 22.5			
Codes/Mitigation Info/Possible Solution		Field Measurements/Component Compliance

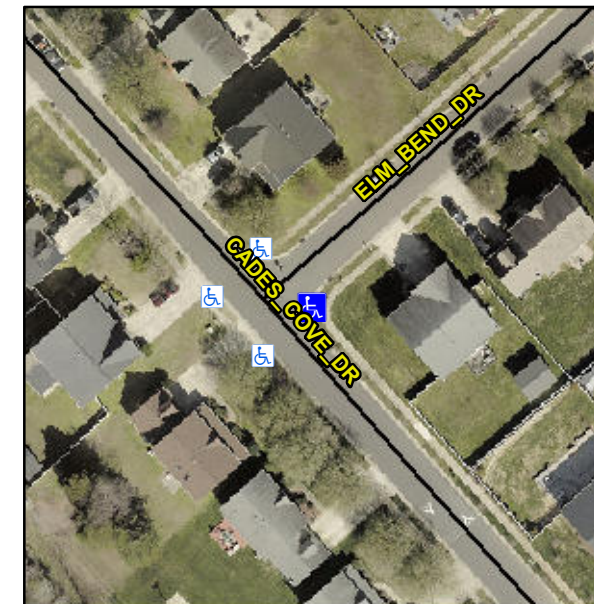
Compliance	Description	Data	Compliance	Description	Data
N/A	Ramp Length (in)	48.0	No	Ramp Slope (%)	11.2
No	Ramp Width (in)	46.5	No	Ramp XSlope (%)	2.3
N/A	Flare Type LT	N/A	N/A	Flare Type RT	N/A
N/A	Flare Slope LT (%)	N/A	N/A	Flare Slope RT (%)	N/A
N/A	Flare Traversable LT?	N/A	N/A	Flare Traversable RT?	N/A
N/A	Landing Length (in)	N/A	N/A	DWS Provided?	N/A
N/A	Landing Width (in)	N/A	N/A	DWS Contrast?	N/A
N/A	Landing Slope (%)	N/A	N/A	DWS Length (in)	N/A
N/A	Landing X Slope (%)	N/A	N/A	DWS Full Width?	N/A
N/A	Landing Curb? (Y/N)	N/A	N/A	DWS Offset (in)	N/A
N/A	Shared Landing?	N/A			
N/A	Gutter Ponding?	N/A	N/A	Gutter Slope (%)	N/A
N/A	Gutter Lip Ht (in)	N/A	N/A	Gutter X Slope (%)	N/A
N/A	Painted X Walk1?	No	N/A	Painted X Walk2?	No
	X Walk 1 Direction	To NW		X Walk 2 Direction	To SW
N/A	X Walk 1 Width (in)	N/A	N/A	X Walk 2 Width (in)	N/A
	X Walk 1 Slope (%)	5.0		X Walk 2 Slope (%)	1.2
	X Walk 1 X Slope (%)	0.8		X Walk 2 X Slope (%)	3.9

N/A	Ramp inside XWalk1?	N/A	N/A	Ramp inside XWalk2?	N/A
	Road Slope (%)	2.5	N/A	Clear Space?	N/A
	Road X Slope (%)	6.1	N/A	Clear Space to XWalk (in)	N/A
N/A	Any Obstructions?	N/A	N/A	Storm Grate/Utility Hazard?	N/A
	Obstruction Type			Storm Grate/Utility Type	
		N/A			N/A
			Yes	Surface Condition? (G/P)	Good

Possible Solutions:

Remove & Replace Curb Ramp With Two New Directional Ramps or Equivalent.
