Access Compliance Report

Public Rights-of-Way

(Curb Ramps)

| Intersection ID: 46695 | Main Street: GOLDFIELDS_DR | Cross Street: TROTTERS_RIDGE_RD | Location: NW |

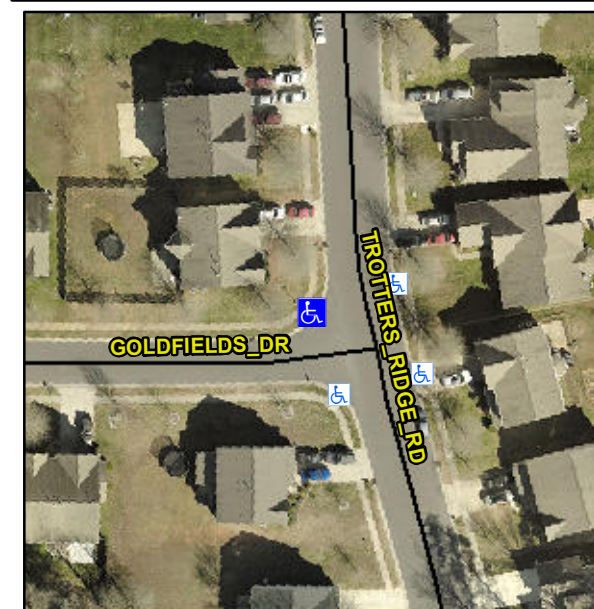
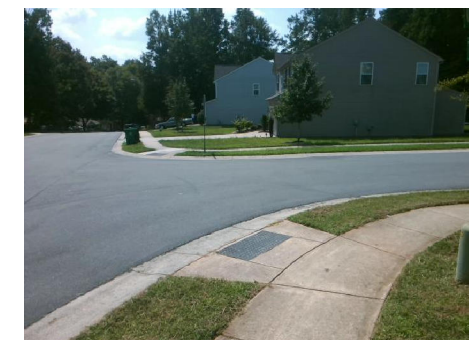
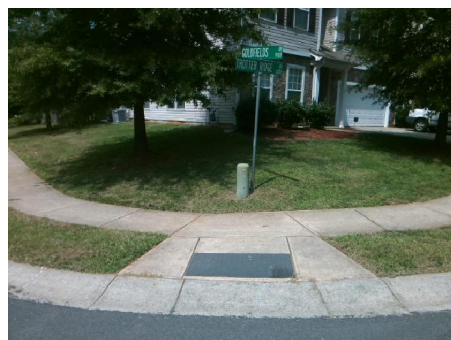
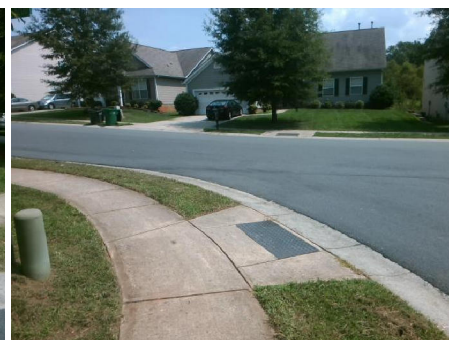
Not Found, R304.5.3

| Compliance | Description | Data | Compliance | Description | Data |
|---|---|---|---|---|---|
| N/A | Ramp Length (in) | 47.0 | Yes | Ramp Slope (%) | 5.9 |
| Yes | Ramp Width (in) | 48.0 | No | Ramp XSlope (%) | 5.4 |

Remove & Replace Curb Ramp With Two New Directional Ramps or Equivalent.
