# Access Compliance Report

## Public Rights-of-Way

### (Curb Ramps)

Intersection ID: 8835	Main Street: BRADFORD_DR	Cross Street: NORTH_AV	Location: SW
ADA ID: 13C299780E2F	Ramp Type: BlendTrans2	Initial Pass/Fail: Fail	Overall Compliance: No
Severity Score: 1.25			
Codes/Mitigation Info/Possible Solution		Field Measurements/Component Compliance

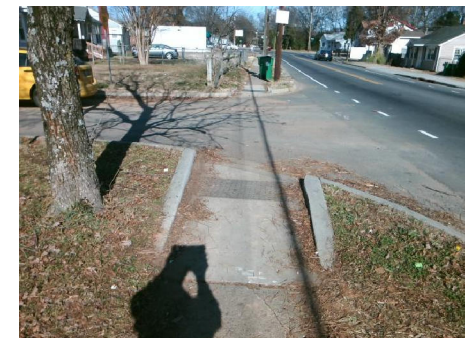
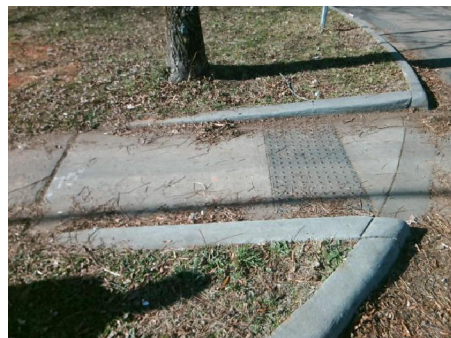
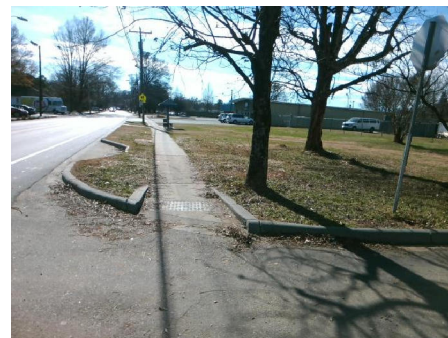
**Not Found, R304.5.3**

Compliance	Description	Data	Compliance	Description	Data
N/A	Ramp Length (in)	84.0	Yes	BlendTrans Slope (%)	2.8
Yes	Ramp Width (in)	48.0	No	BlendTrans XSlope (%)	2.1
N/A	Flare Type LT	N/A	N/A	Flare Type RT	N/A
N/A	Flare Slope LT (%)	N/A	N/A	Flare Slope RT (%)	N/A
N/A	Flare Traversable LT?	N/A	N/A	Flare Traversable RT?	N/A
N/A	Landing Length (in)	N/A	N/A	DWS Provided?	N/A
N/A	Landing Width (in)	N/A	N/A	DWS Contrast?	N/A
N/A	Landing Slope (%)	N/A	N/A	DWS Length (in)	N/A
N/A	Landing X Slope (%)	N/A	N/A	DWS Full Width?	N/A
N/A	Landing Curb? (Y/N)	N/A	N/A	DWS Offset (in)	N/A
N/A	Shared Landing?	N/A			
N/A	Gutter Ponding?	N/A	N/A	Gutter Slope (%)	N/A
N/A	Gutter Lip Ht (in)	N/A	N/A	Gutter X Slope (%)	N/A
N/A	Painted X Walk1?	No	N/A	Painted X Walk2?	N/A
	X Walk 1 Direction	To N		X Walk 2 Direction	N/A
	X Walk 1 Width (in)	N/A		X Walk 2 Width (in)	N/A
	X Walk 1 Slope (%)	1.7		X Walk 2 Slope (%)	N/A
	X Walk 1 X Slope (%)	1.1		X Walk 2 X Slope (%)	N/A

N/A	Ramp inside XWalk1?	N/A	N/A	Ramp inside XWalk2?	N/A
	Road Slope (%)	1.1		Clear Space?	N/A
	Road X Slope (%)	1.7	N/A	Clear Space to XWalk (in)	N/A
N/A	Any Obstructions?	N/A	N/A	Storm Grate/Utility Hazard?	N/A
	Obstruction Type			Storm Grate/Utility Type	
		N/A			N/A
			Yes	Surface Condition? (G/P)	Good
			No	Curb Slope (%)	11.9

**Remove & Replace Curb Ramp With Two New Directional Ramps or Equivalent.**

Total Cost: \$ 3200.00
