Access Compliance Report

Public Rights-of-Way

(Curb Ramps)

Intersection ID: 49925	Main Street: PAXTON_RUN_RD	Cross Street: CAMPBELL_HALL_CT	Location: NW
ADA ID: 13C9FCC79A02	Ramp Type: Perp	Initial Pass/Fail: Fail	Overall Compliance: No
Severity Score: 25			
Codes/Mitigation Info/Possible Solution		Field Measurements/Component Compliance

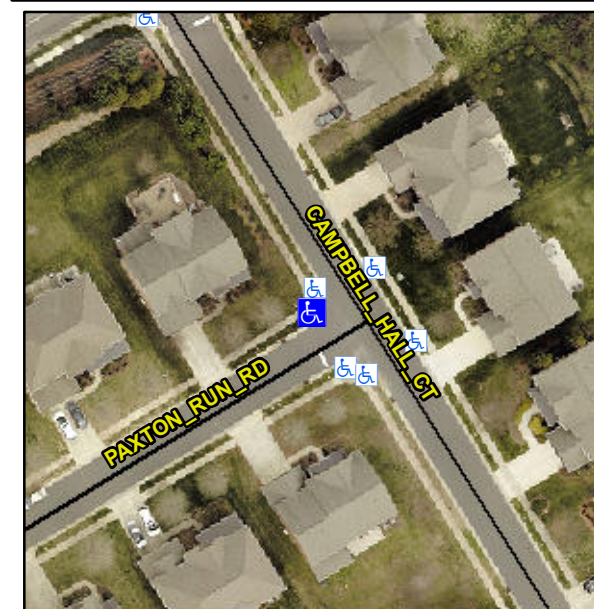
Not Found, R304.2.2

Compliance	Description	Data	Compliance	Description	Data
N/A	Ramp Length (in)	45.0	No	Ramp Slope (%)	14.7
Yes	Ramp Width (in)	48.0	Yes	Ramp XSlope (%)	0.5
N/A	Flare Type LT	N/A	N/A	Flare Type RT	N/A
N/A	Flare Slope LT (%)	N/A	N/A	Flare Slope RT (%)	N/A
N/A	Flare Traversable LT?	N/A	N/A	Flare Traversable RT?	N/A
N/A	Landing Length (in)	N/A	N/A	DWS Provided?	N/A
N/A	Landing Width (in)	N/A	N/A	DWS Contrast?	N/A
N/A	Landing Slope (%)	N/A	N/A	DWS Length (in)	N/A
N/A	Landing X Slope (%)	N/A	N/A	DWS Full Width?	N/A
N/A	Landing Curb? (Y/N)	N/A	N/A	DWS Offset (in)	N/A
N/A	Shared Landing?	N/A			
N/A	Gutter Ponding?	N/A	N/A	Gutter Slope (%)	N/A
N/A	Gutter Lip Ht (in)	N/A	N/A	Gutter X Slope (%)	N/A
N/A	Painted X Walk1?	No	N/A	Painted X Walk2?	N/A
	X Walk 1 Direction	To SE		X Walk 2 Direction	N/A
N/A	X Walk 1 Width (in)	N/A	N/A	X Walk 2 Width (in)	N/A
	X Walk 1 Slope (%)	2.0		X Walk 2 Slope (%)	N/A
	X Walk 1 X Slope (%)	2.0		X Walk 2 X Slope (%)	N/A

N/A	Ramp inside XWalk1?	N/A	N/A	Ramp inside XWalk2?	N/A
	Road Slope (%)	N/A	N/A	Clear Space?	N/A
	Road X Slope (%)	N/A	N/A	Clear Space to XWalk (in)	N/A
N/A	Any Obstructions?	N/A	N/A	Storm Grate/Utility Hazard?	N/A
	Obstruction Type			Storm Grate/Utility Type	
		N/A			N/A
			Yes	Surface Condition? (G/P)	Good

Possible Solutions:

Remove & Replace Entire Ramp.

Total Cost: \$ 1850.00
