# Access Compliance Report

## Public Rights-of-Way

### (Curb Ramps)

| Intersection ID: 53326 | Main Street: FLINT_HILL_DR | Cross Street: CALAWOOD_WY | Location: NE |

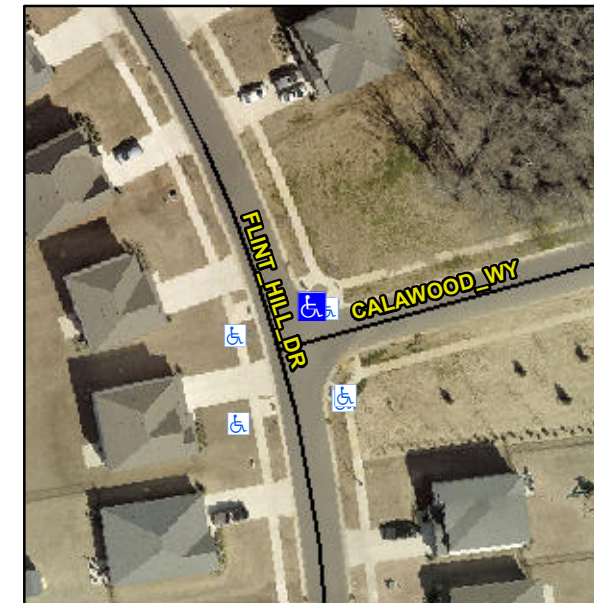
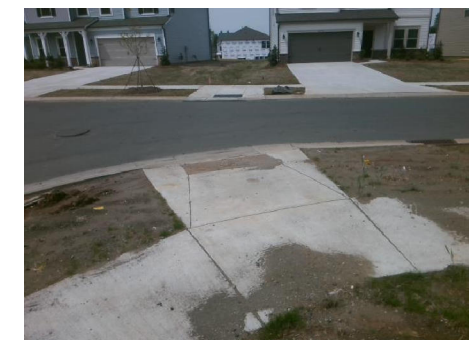
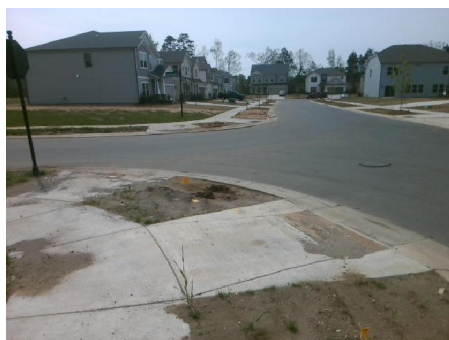
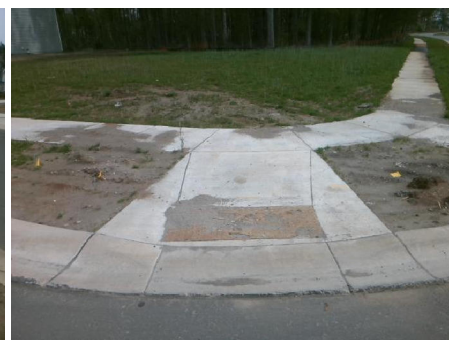
| ADA ID: 13CE31B83323 | Ramp Type: Perp | Initial Pass/Fail: Fail | Overall Compliance: No |
| | | Severity Score: 12.5 | |

| Compliance | Description | Data | Compliance | Description | Data |
|---|---|---|---|---|---|
| N/A | Ramp Length (in) | 99.0 | No | Ramp Slope (%) | 8.8 |
| Yes | Ramp Width (in) | 60.0 | Yes | Ramp XSlope (%) | 1.6 |

**Remove & Replace Entire Ramp.**

**R304.2.2**

**\$ 1850.00**
