# Access Compliance Report

## Public Rights-of-Way

### (Curb Ramps)

| Intersection ID: 14477 | Main Street: WEDDINGTON_AV | Cross Street: BASCOM_ST | Location: W |

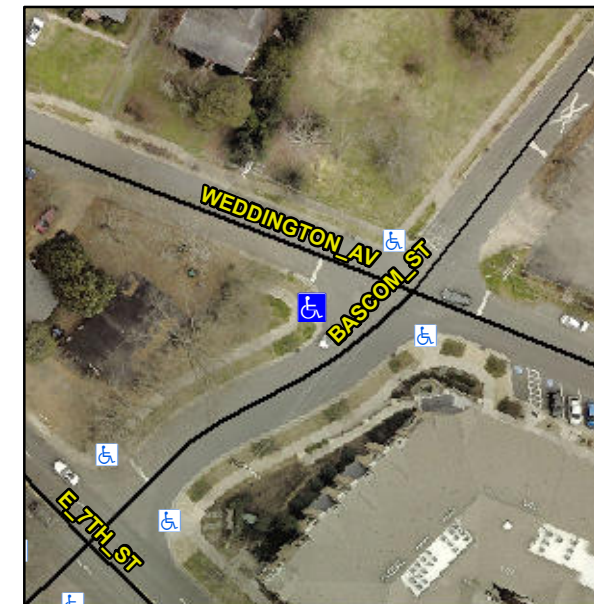
| ADA ID: 13CF61E3E9BF | Ramp Type: PerpDiag | Initial Pass/Fail: Pass | Overall Compliance: No |
| Severity Score: 0.25 | | | |

**Not Found, R304.5.3, R305.2**

| Compliance | Description | Data | Compliance | Description | Data |
|---|---|---|---|---|---|
| Yes | Ramp Width (in) | 48.0 | No | Ramp XSlope (%) | 2.5 |
| N/A | Landing Curb? (Y/N) | No | No | DWS Offset (in) | 6.0 |

**Remove & Replace Curb Ramp With Two New Directional Ramps or Equivalent.**

Total Cost: \$ 3200.00

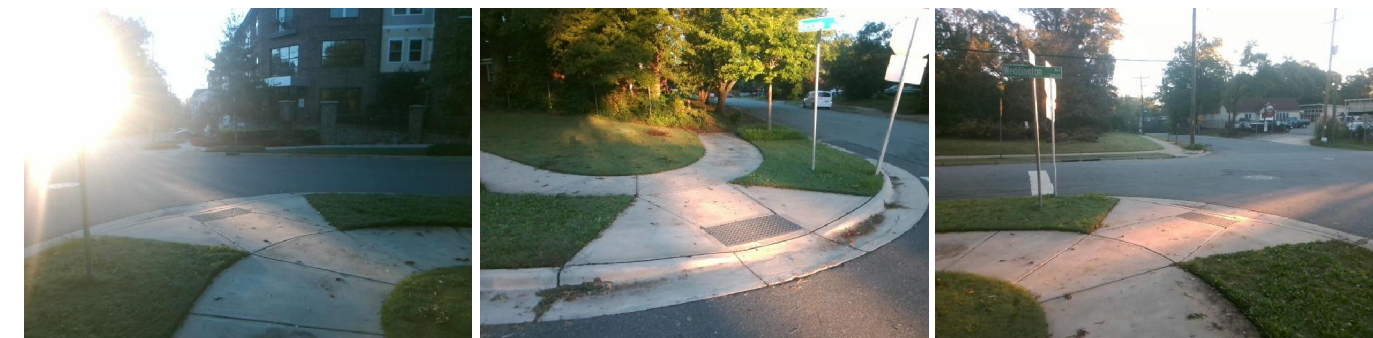
Street 1 Name **BASCOM ST**  
 Stop Condition-Street 2 **None**  
 Street 2 Name **WEDDINGTON AV**  
 Stop Condition-Street 1 **StopSign**
