# Access Compliance Report

## Public Rights-of-Way

### (Curb Ramps)

| Intersection ID: 50632 | Main Street: CORAL_ROSE_RD | Cross Street: RED_WATER_RD | Location: SW |

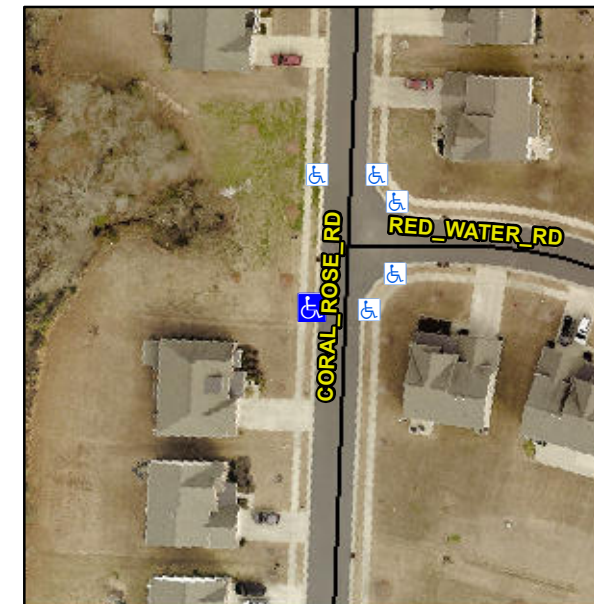
| ADA ID: 13D14941E056 | Ramp Type: Perp | Initial Pass/Fail: Pass | Overall Compliance: No |

**Not Found, R304.5.3, R305.2**

| Compliance | Description | Data | Compliance | Description | Data |
|---|---|---|---|---|---|
| No | Landing X Slope (%) | 5.3 | Yes | DWS Full Width? | Yes |
| N/A | Landing Curb? (Y/N) | No | No | DWS Offset (in) | 4.5 |

**Remove & Replace Entire Ramp.**

Total Cost: \$ 1850.00
