Access Compliance Report

Public Rights-of-Way

(Curb Ramps)

Intersection ID: 11564	Main Street: BRIXTON_CT	Cross Street: HILLIARD_DR	Location: SW
ADA ID: 13D2F837DF72	Ramp Type: Perp	Initial Pass/Fail: Fail	Overall Compliance: No
		Severity Score: 10

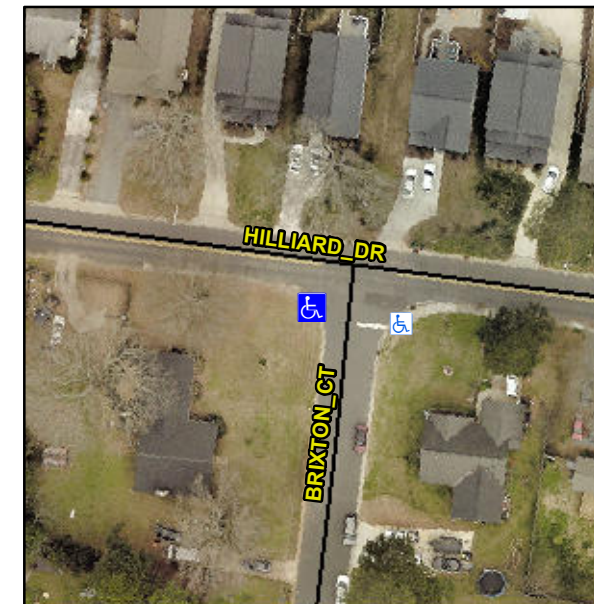
Not Found, R304.5.1, R304.5.3

Compliance	Description	Data	Compliance	Description	Data
N/A	Ramp Length (in)	58.0	Yes	Ramp Slope (%)	6.3
No	Ramp Width (in)	38.5	No	Ramp XSlope (%)	3.6
N/A	Flare Type LT	N/A	N/A	Flare Type RT	N/A
N/A	Flare Slope LT (%)	N/A	N/A	Flare Slope RT (%)	N/A
N/A	Flare Traversable LT?	N/A	N/A	Flare Traversable RT?	N/A
N/A	Landing Length (in)	N/A	N/A	DWS Provided?	N/A
N/A	Landing Width (in)	N/A	N/A	DWS Contrast?	N/A
N/A	Landing Slope (%)	N/A	N/A	DWS Length (in)	N/A
N/A	Landing X Slope (%)	N/A	N/A	DWS Full Width?	N/A
N/A	Landing Curb? (Y/N)	N/A	N/A	DWS Offset (in)	N/A
N/A	Shared Landing?	N/A			
N/A	Gutter Ponding?	N/A	N/A	Gutter Slope (%)	N/A
N/A	Gutter Lip Ht (in)	N/A	N/A	Gutter X Slope (%)	N/A
N/A	Painted X Walk1?	No	N/A	Painted X Walk2?	N/A
	X Walk 1 Direction	To E		X Walk 2 Direction	N/A
N/A	X Walk 1 Width (in)	N/A	N/A	X Walk 2 Width (in)	N/A
	X Walk 1 Slope (%)	0.5		X Walk 2 Slope (%)	N/A
	X Walk 1 X Slope (%)	3.5		X Walk 2 X Slope (%)	N/A

N/A	Ramp inside XWalk1?	N/A	N/A	Ramp inside XWalk2?	N/A
	Road Slope (%)	N/A	N/A	Clear Space?	N/A
	Road X Slope (%)	N/A	N/A	Clear Space to XWalk (in)	N/A
N/A	Any Obstructions?	N/A	N/A	Storm Grate/Utility Hazard?	N/A
	Obstruction Type			Storm Grate/Utility Type	
		N/A			N/A
		Yes		Surface Condition? (G/P)	Good

Possible Solutions:

Remove & Replace Entire Ramp.
