# Access Compliance Report

## Public Rights-of-Way

| Intersection ID: 29111 | Main Street: ARBOR_SPRING_DR | Cross Street: HERON_GLEN_DR | Location: S |
| ADA ID: 13DC0345622A | Ramp Type: BlendTrans1 | Initial Pass/Fail: Pass | Overall Compliance: No |

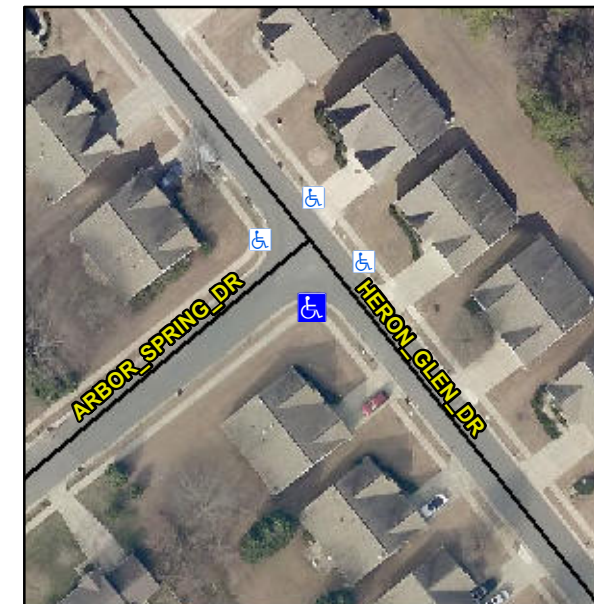
| | | | Severity Score: 14.25 |

| Compliance | Description | Data | Compliance | Description | Data |
|---|---|---|---|---|---|
| N/A | Ramp Length (in) | 47.0 | Yes | BlendTrans Slope (%) | 3.8 |
| Yes | Ramp Width (in) | 48.0 | No | BlendTrans XSlope (%) | 2.6 |
| No | Landing Length (in) | 47.0 | No | DWS Provided? | No |
| No | Landing Width (in) | 40.0 | N/A | DWS Contrast? | No |

**Remove & Replace Curb Ramp With Two New Directional Ramps or Equivalent.**

**R304.5.3, R304.2.1, R305**

Total Cost: \$ 3200.00
