# Access Compliance Report

## Public Rights-of-Way

### (Curb Ramps)

Intersection ID: 42368	Main Street: FAIRVISTA_DR	Cross Street: HIGHLAND_CREEK_PY	Location: NE
ADA ID: 13E580FDD8E5	Ramp Type: PerpDiag	Initial Pass/Fail: Fail	Overall Compliance: No
		Severity Score: 37.5

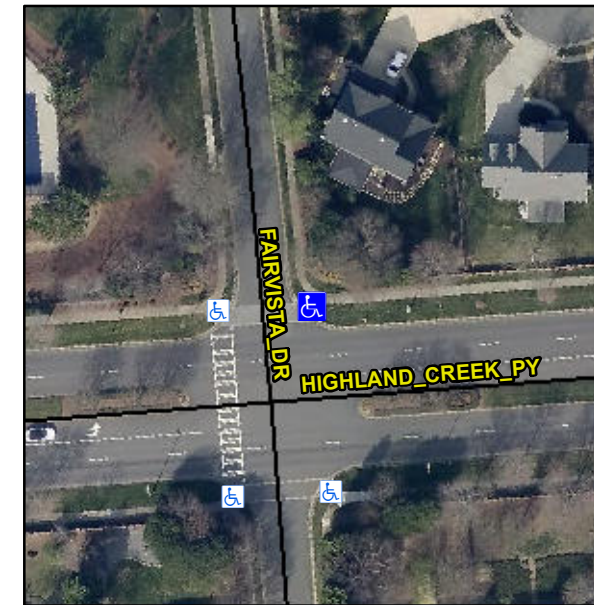
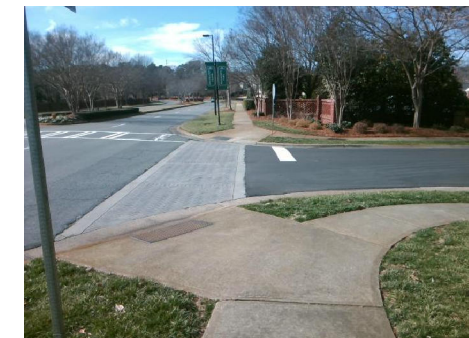
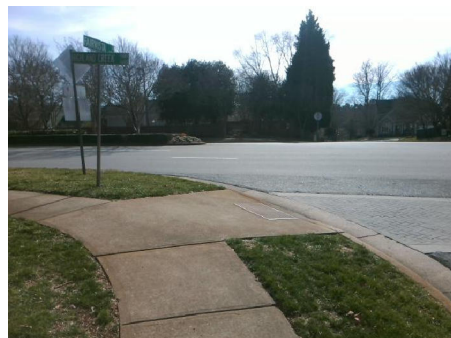
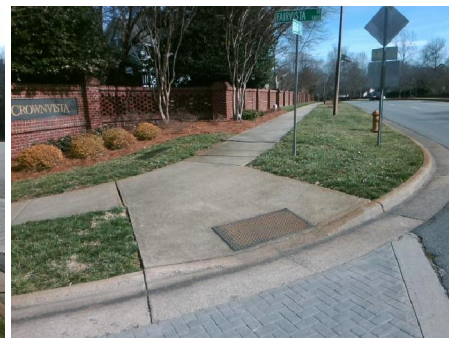
**Not Found, R304.2.2, R304.5.3**

Compliance	Description	Data	Compliance	Description	Data
N/A	Ramp Length (in)	73.0	No	Ramp Slope (%)	12.7
Yes	Ramp Width (in)	48.0	No	Ramp XSlope (%)	6.8
N/A	Flare Type LT	N/A	N/A	Flare Type RT	N/A
N/A	Flare Slope LT (%)	N/A	N/A	Flare Slope RT (%)	N/A
N/A	Flare Traversable LT?	N/A	N/A	Flare Traversable RT?	N/A
N/A	Landing Length (in)	N/A	N/A	DWS Provided?	N/A
N/A	Landing Width (in)	N/A	N/A	DWS Contrast?	N/A
N/A	Landing Slope (%)	N/A	N/A	DWS Length (in)	N/A
N/A	Landing X Slope (%)	N/A	N/A	DWS Full Width?	N/A
N/A	Landing Curb? (Y/N)	N/A	N/A	DWS Offset (in)	N/A
N/A	Shared Landing?	N/A			
N/A	Gutter Ponding?	N/A	N/A	Gutter Slope (%)	N/A
N/A	Gutter Lip Ht (in)	N/A	N/A	Gutter X Slope (%)	N/A
N/A	Painted X Walk1?	Yes	N/A	Painted X Walk2?	No
	X Walk 1 Direction	To W		X Walk 2 Direction	To S
N/A	X Walk 1 Width (in)	120.0	N/A	X Walk 2 Width (in)	N/A
	X Walk 1 Slope (%)	1.1		X Walk 2 Slope (%)	5.0
	X Walk 1 X Slope (%)	4.2		X Walk 2 X Slope (%)	0.7

N/A	Ramp inside XWalk1?	Yes	N/A	Ramp inside XWalk2?	N/A
	Road Slope (%)	5.0	N/A	Clear Space?	N/A
	Road X Slope (%)	4.4	N/A	Clear Space to XWalk (in)	N/A
N/A	Any Obstructions?	N/A	N/A	Storm Grate/Utility Hazard?	N/A
	Obstruction Type			Storm Grate/Utility Type	
		N/A			N/A
		Yes		Surface Condition? (G/P)	Good

**Remove & Replace Curb Ramp With Two New Directional Ramps or Equivalent.**
