# Access Compliance Report

## Public Rights-of-Way

### (Curb Ramps)

Intersection ID: 10036962	Main Street: S_TRYON_ST	Cross Street: N/A	Location: NW
ADA ID: 14003130212C	Ramp Type: Perp	Initial Pass/Fail: Fail	Overall Compliance: No
Severity Score: 1.25			
Codes/Mitigation Info/Possible Solution		Field Measurements/Component Compliance

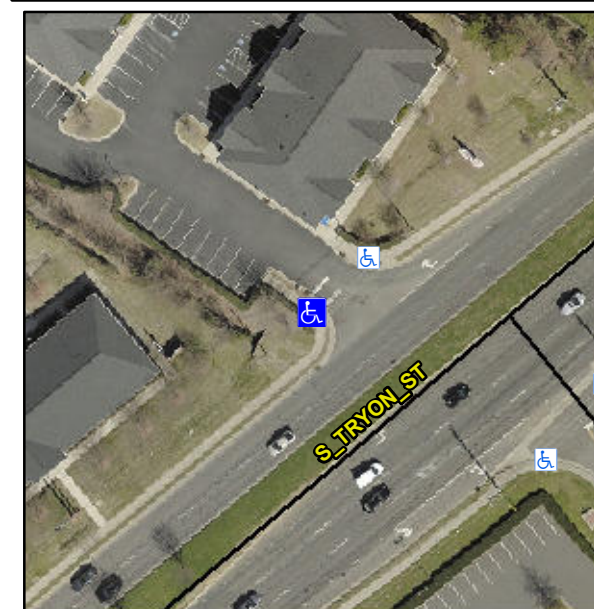
**Not Found, R304.5.3**

Compliance	Description	Data	Compliance	Description	Data
N/A	Ramp Length (in)	90.0	Yes	Ramp Slope (%)	5.7
Yes	Ramp Width (in)	48.0	No	Ramp XSlope (%)	2.8
N/A	Flare Type LT	N/A	N/A	Flare Type RT	N/A
N/A	Flare Slope LT (%)	N/A	N/A	Flare Slope RT (%)	N/A
N/A	Flare Traversable LT?	N/A	N/A	Flare Traversable RT?	N/A
N/A	Landing Length (in)	N/A	N/A	DWS Provided?	N/A
N/A	Landing Width (in)	N/A	N/A	DWS Contrast?	N/A
N/A	Landing Slope (%)	N/A	N/A	DWS Length (in)	N/A
N/A	Landing X Slope (%)	N/A	N/A	DWS Full Width?	N/A
N/A	Landing Curb? (Y/N)	N/A	N/A	DWS Offset (in)	N/A
N/A	Shared Landing?	N/A			
N/A	Gutter Ponding?	N/A	N/A	Gutter Slope (%)	N/A
N/A	Gutter Lip Ht (in)	N/A	N/A	Gutter X Slope (%)	N/A
N/A	Painted X Walk1?	Yes	N/A	Painted X Walk2?	N/A
	X Walk 1 Direction	To NE		X Walk 2 Direction	N/A
N/A	X Walk 1 Width (in)	47.0	N/A	X Walk 2 Width (in)	N/A
	X Walk 1 Slope (%)	1.2		X Walk 2 Slope (%)	N/A
	X Walk 1 X Slope (%)	1.5		X Walk 2 X Slope (%)	N/A

N/A	Ramp inside XWalk1?	Yes	N/A	Ramp inside XWalk2?	N/A
	Road Slope (%)	N/A	N/A	Clear Space?	N/A
	Road X Slope (%)	N/A	N/A	Clear Space to XWalk (in)	N/A
N/A	Any Obstructions?	N/A	N/A	Storm Grate/Utility Hazard?	N/A
	Obstruction Type			Storm Grate/Utility Type	
		N/A			N/A
		Yes		Surface Condition? (G/P)	Good

Possible Solutions:

**Remove & Replace Entire Ramp.**
