# Access Compliance Report

## Public Rights-of-Way

### (Curb Ramps)

Intersection ID: 15195	Main Street: ALBEMARLE_RD	Cross Street: FARM_POND_LN	Location: NE
ADA ID: 140790009047	Ramp Type: Perp	Initial Pass/Fail: Fail	Overall Compliance: No
Severity Score: 26.25			
Codes/Mitigation Info/Possible Solution		Field Measurements/Component Compliance

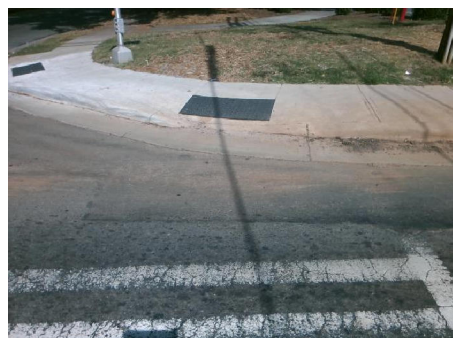
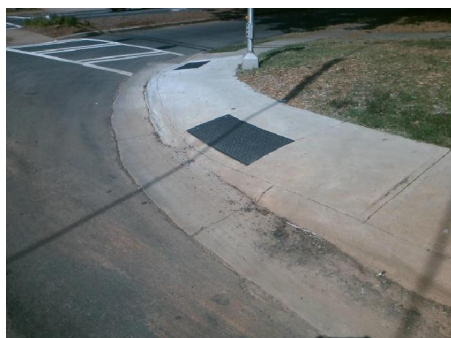
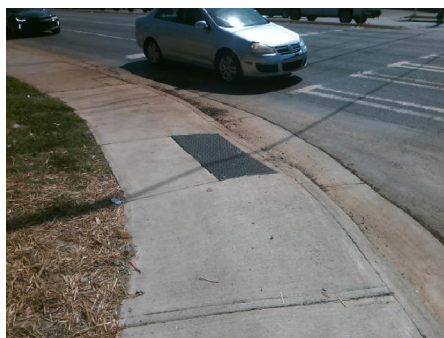
**Not Found, R304.2.2**

Compliance	Description	Data	Compliance	Description	Data
N/A	Ramp Length (in)	57.0	No	Ramp Slope (%)	13.7
Yes	Ramp Width (in)	48.0	Yes	Ramp XSlope (%)	3.3
N/A	Flare Type LT	N/A	N/A	Flare Type RT	N/A
N/A	Flare Slope LT (%)	N/A	N/A	Flare Slope RT (%)	N/A
N/A	Flare Traversable LT?	N/A	N/A	Flare Traversable RT?	N/A
N/A	Landing Length (in)	N/A	N/A	DWS Provided?	N/A
N/A	Landing Width (in)	N/A	N/A	DWS Contrast?	N/A
N/A	Landing Slope (%)	N/A	N/A	DWS Length (in)	N/A
N/A	Landing X Slope (%)	N/A	N/A	DWS Full Width?	N/A
N/A	Landing Curb? (Y/N)	N/A	N/A	DWS Offset (in)	N/A
N/A	Shared Landing?	N/A			
N/A	Gutter Ponding?	Yes	N/A	Gutter Slope (%)	N/A
N/A	Gutter Lip Ht (in)	N/A	N/A	Gutter X Slope (%)	N/A
N/A	Painted X Walk1?	Yes	N/A	Painted X Walk2?	N/A
	X Walk 1 Direction	To S		X Walk 2 Direction	N/A
N/A	X Walk 1 Width (in)	110.0	N/A	X Walk 2 Width (in)	N/A
	X Walk 1 Slope (%)	2.7		X Walk 2 Slope (%)	N/A
	X Walk 1 X Slope (%)	5.1		X Walk 2 X Slope (%)	N/A

N/A	Ramp inside XWalk1?	Yes	N/A	Ramp inside XWalk2?	N/A
	Road Slope (%)	N/A	N/A	Clear Space?	N/A
	Road X Slope (%)	N/A	N/A	Clear Space to XWalk (in)	N/A
N/A	Any Obstructions?	N/A	N/A	Storm Grate/Utility Hazard?	N/A
	Obstruction Type			Storm Grate/Utility Type	
		N/A			N/A
		Yes		Surface Condition? (G/P)	Good

**Remove & Replace Entire Ramp.**

Total Cost: \$ 1850.00
