# Access Compliance Report

## Public Rights-of-Way

### (Curb Ramps)

| Intersection ID: N/A | Main Street: MORABLIN_DR | Cross Street: CORLISS_AV | Location: SE |

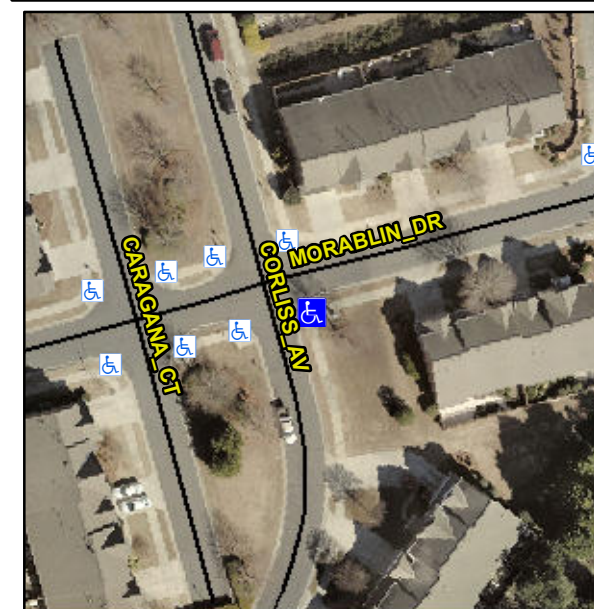
| ADA ID: 14093C1A49D0 | Ramp Type: PerpDiag | Initial Pass/Fail: Pass | Overall Compliance: No |

**Not Found, R304.5.3, R304.2.1, R304.2.2-Perp, R304.3.2-Para, R305, R304.5.4**

| Compliance | Description | Data | Compliance | Description | Data |
|---|---|---|---|---|---|
| Yes | Ramp Width (in) | 48.0 | No | Ramp XSlope (%) | 2.4 |
| No | Landing Length (in) | N/A | No | DWS Provided? | No |
| Yes | Gutter Ponding? | No | No | Gutter Slope (%) | 5.9 |

**Remove & Replace Curb Ramp With Two New Directional Ramps or Equivalent. Remove & Replace Gutter.**
