Access Compliance Report

Public Rights-of-Way

(Curb Ramps)

Intersection ID: 10161	Main Street: E_35TH_ST	Cross Street: YADKIN_AV	Location: W
ADA ID: 1417E6B17C15	Ramp Type: BlendTrans2	Initial Pass/Fail: Fail	Overall Compliance: No
Severity Score: 30			
Codes/Mitigation Info/Possible Solution		Field Measurements/Component Compliance

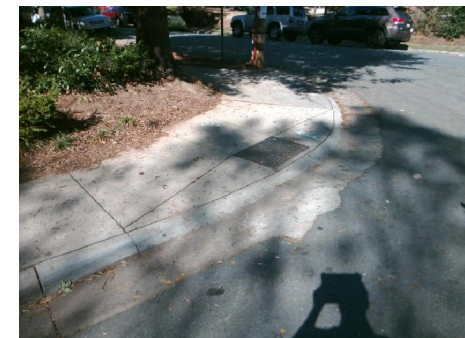
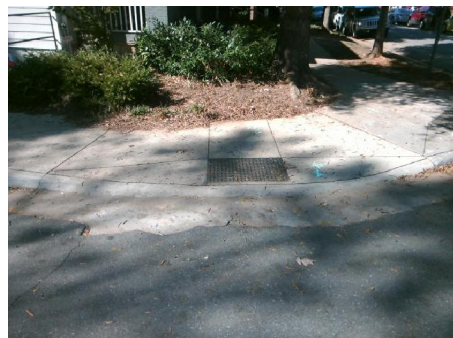
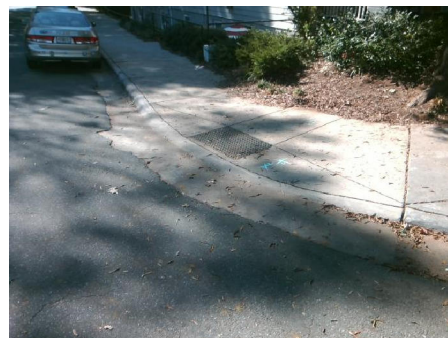
Not Found, R304.5.1, R304.5.3

Compliance	Description	Data	Compliance	Description	Data
N/A	Ramp Length (in)	83.5	Yes	BlendTrans Slope (%)	4.3
No	Ramp Width (in)	35.5	No	BlendTrans XSlope (%)	5.5
N/A	Flare Type LT	N/A	N/A	Flare Type RT	N/A
N/A	Flare Slope LT (%)	N/A	N/A	Flare Slope RT (%)	N/A
N/A	Flare Traversable LT?	N/A	N/A	Flare Traversable RT?	N/A
N/A	Landing Length (in)	N/A	N/A	DWS Provided?	N/A
N/A	Landing Width (in)	N/A	N/A	DWS Contrast?	N/A
N/A	Landing Slope (%)	N/A	N/A	DWS Length (in)	N/A
N/A	Landing X Slope (%)	N/A	N/A	DWS Full Width?	N/A
N/A	Landing Curb? (Y/N)	N/A	N/A	DWS Offset (in)	N/A
N/A	Shared Landing?	N/A			
N/A	Gutter Ponding?	N/A	N/A	Gutter Slope (%)	N/A
N/A	Gutter Lip Ht (in)	N/A	N/A	Gutter X Slope (%)	N/A
N/A	Painted X Walk1?	No	N/A	Painted X Walk2?	N/A
	X Walk 1 Direction	To SE		X Walk 2 Direction	N/A
	X Walk 1 Width (in)	N/A		X Walk 2 Width (in)	N/A
	X Walk 1 Slope (%)	3.1		X Walk 2 Slope (%)	N/A
	X Walk 1 X Slope (%)	2.7		X Walk 2 X Slope (%)	N/A

N/A	Ramp inside XWalk1?	N/A	N/A	Ramp inside XWalk2?	N/A
	Road Slope (%)	2.7		Clear Space?	N/A
	Road X Slope (%)	3.1	N/A	Clear Space to XWalk (in)	N/A
N/A	Any Obstructions?	N/A	N/A	Storm Grate/Utility Hazard?	N/A
	Obstruction Type			Storm Grate/Utility Type	
		N/A			N/A
			Yes	Surface Condition? (G/P)	Good
			No	Curb Slope (%)	11.1

Remove & Replace Curb Ramp With Two New Directional Ramps or Equivalent.
