Access Compliance Report

Public Rights-of-Way

(Curb Ramps)

Intersection ID: 6774	Main Street: STETSON_DR	Cross Street: N_TRYON_ST	Location:	N
ADA ID: 141E4B11BD6E	Ramp Type: Directional1	Initial Pass/Fail: Fail	Overall Compliance: No	Severity Score: 1.25
Codes/Mitigation Info/Possible Solution		Field Measurements/Component Compliance

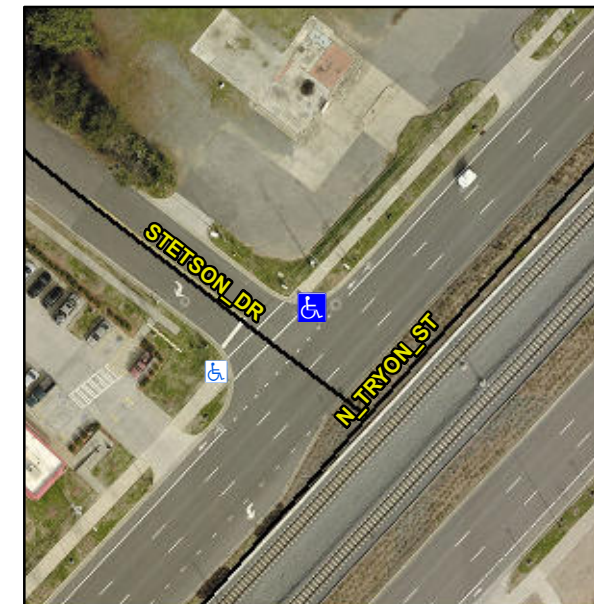
Compliance	Description	Data	Compliance	Description	Data
N/A	Ramp Length (in)	88.5	N/A	Grade Break?	N/A
Yes	Ramp Width (in)	71.0	N/A	Grade Break Slope (%)	0.0
Yes	Ramp Slope (%)	8.0	N/A	Grade Break XSlope (%)	0.0
No	Ramp XSlope (%)	2.4			
N/A	Flare Type LT	N/A	N/A	Flare Type RT	N/A
N/A	Flare Slope LT (%)	N/A	N/A	Flare Slope RT (%)	0.0
N/A	Flare Traversable LT?	N/A	N/A	Flare Traversable RT?	N/A
N/A	Landing Length (in)	0.0	N/A	DWS Provided?	N/A
N/A	Landing Width (in)	0.0	N/A	DWS Contrast?	N/A
N/A	Landing Slope (%)	0.0	N/A	DWS Length (in)	N/A
N/A	Landing X Slope (%)	0.0	N/A	DWS Full Width?	N/A
N/A	Landing Curb? (Y/N)	N/A	N/A	DWS Offset LT (in)	N/A
N/A	Shared Landing?	N/A	N/A	DWS Offset RT (in)	N/A
N/A	Gutter Ponding?	0.0	N/A	Gutter Slope (%)	N/A
N/A	Gutter Lip Ht (in)	0.0	N/A	Gutter X Slope (%)	N/A
N/A	Painted X Walk1?	Yes		Road Slope (%)	4.3
	X Walk 1 Direction	To SW		Road X Slope (%)	4.7
	X Walk 1 Width (in)	110.0		Clear Space?	N/A

X Walk 1 Slope (%)	4.3	N/A	Clear Space to XWalk (in)	N/A
	X Walk 1 X Slope (%)	4.7	N/A	Storm Grate/Utility Hazard?	N/A
N/A	Ramp inside XWalk1?	Yes		Storm Grate/Utility Type	
N/A	Any Obstructions?	N/A			N/A
	Obstruction Type		Yes	Surface Condition? (G/P)	Good
			N/A	Curb Slope (%)	1.0

Possible Solutions:

Remove & Replace Entire Ramp.

PROW/ADA:

R304.5.3
