Access Compliance Report

Public Rights-of-Way

(Curb Ramps)

Intersection ID: 5708	Main Street: PLEASANT GROVE RD	Cross Street: OAKDALE GREEN DR	Location: SE
ADA ID: 1427B5137EAF	Ramp Type: Perp	Initial Pass/Fail: Fail	Overall Compliance: No
Severity Score: 8.75			
Codes/Mitigation Info/Possible Solution		Field Measurements/Component Compliance

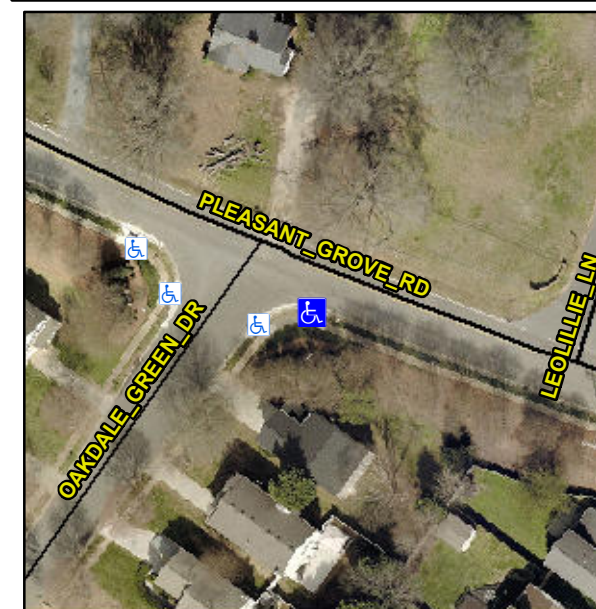
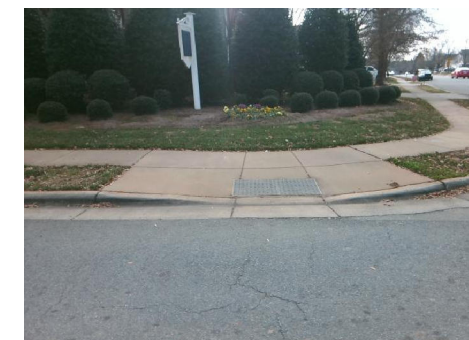
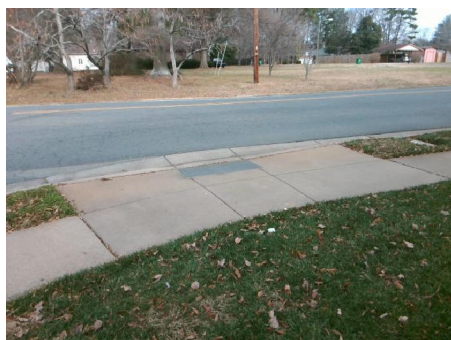
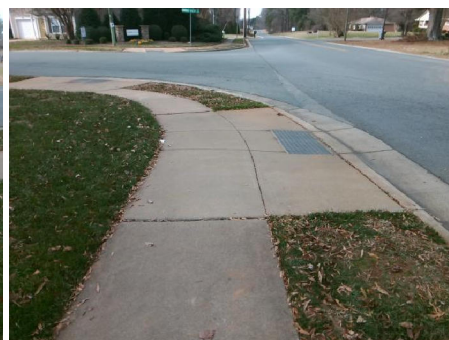
Compliance	Description	Data	Compliance	Description	Data
N/A	Ramp Length (in)	47.0	Yes	Ramp Slope (%)	6.8
No	Ramp Width (in)	40.0	Yes	Ramp XSlope (%)	1.0
N/A	Flare Type LT	N/A	N/A	Flare Type RT	N/A
N/A	Flare Slope LT (%)	N/A	N/A	Flare Slope RT (%)	N/A
N/A	Flare Traversable LT?	N/A	N/A	Flare Traversable RT?	N/A
N/A	Landing Length (in)	N/A	N/A	DWS Provided?	N/A
N/A	Landing Width (in)	N/A	N/A	DWS Contrast?	N/A
N/A	Landing Slope (%)	N/A	N/A	DWS Length (in)	N/A
N/A	Landing X Slope (%)	N/A	N/A	DWS Full Width?	N/A
N/A	Landing Curb? (Y/N)	N/A	N/A	DWS Offset (in)	N/A
N/A	Shared Landing?	N/A			
N/A	Gutter Ponding?	N/A	N/A	Gutter Slope (%)	N/A
N/A	Gutter Lip Ht (in)	N/A	N/A	Gutter X Slope (%)	N/A
N/A	Painted X Walk1?	No	N/A	Painted X Walk2?	N/A
	X Walk 1 Direction	To N		X Walk 2 Direction	N/A
N/A	X Walk 1 Width (in)	N/A	N/A	X Walk 2 Width (in)	N/A
	X Walk 1 Slope (%)	5.0		X Walk 2 Slope (%)	N/A
	X Walk 1 X Slope (%)	2.0		X Walk 2 X Slope (%)	N/A

N/A	Ramp inside XWalk1?	N/A	N/A	Ramp inside XWalk2?	N/A
	Road Slope (%)	2.0	N/A	Clear Space?	N/A
	Road X Slope (%)	5.0	N/A	Clear Space to XWalk (in)	N/A
N/A	Any Obstructions?	N/A	N/A	Storm Grate/Utility Hazard?	N/A
	Obstruction Type			Storm Grate/Utility Type	
		N/A			N/A
		Yes		Surface Condition? (G/P)	Good

Possible Solutions:

Remove & Replace Entire Ramp.
