Access Compliance Report Public Rights-of-Way (Curb Ramps)

Intersection ID: 42963 Main Street: RED_ROBIN_ST Cross Street: PRAIRIEGROUSE_CT Location: E

ADA ID: 143A0C5C4E3E Ramp Type: PerpDiag Initial Pass/Fail: Fail Overall Compliance: No Severity Score: 46.25

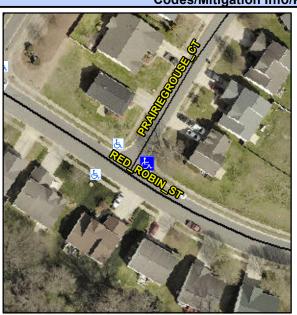
Not Found, R304.5.1, R304.2.2,
R304.5.3

Field Measurements/Component Compliance						
Compliance Description		Data	Comp	liance Des	cription	Data
N/A	Ramp Length (in)	46.0	No	Ramp Slop	pe (%)	8.4
No	Ramp Width (in)	46.0	No	Ramp XSI	ope (%)	15.0
N/A	Flare Type LT	N/A	N/A	Flare Type	RT	N/A
N/A	Flare Slope LT (%)	N/A	N/A	Flare Slop	e RT (%)	N/A
N/A	Flare Traversable LT?	N/A	N/A	Flare Trav	ersable RT?	N/A
N/A	Landing Length (in)	N/A	N/A	DWS Prov	rided?	N/A
N/A	Landing Width (in)	N/A	N/A	DWS Con	trast?	N/A
N/A	Landing Slope (%)	N/A	N/A	DWS Leng	gth (in)	N/A
N/A	Landing X Slope (%)	N/A	N/A	DWS Full	Width?	N/A
N/A	Landing Curb? (Y/N)	N/A	N/A	DWS Offs	et (in)	N/A
N/A	Shared Landing?	N/A				
N/A	Gutter Ponding?	N/A	N/A	Gutter Slo	pe (%)	N/A
N/A	Gutter Lip Ht (in)	N/A	N/A	Gutter X S	lope (%)	N/A
N/A	Painted X Walk1?	No	N/A	Painted X	Walk2?	No
	X Walk 1 Direction	To NW		X Walk 2 [Direction	To SW
N/A	X Walk 1 Width (in)	N/A	N/A	X Walk 2 \	Width (in)	N/A
	X Walk 1 Slope (%)	8.4		X Walk 2 S	Slope (%)	2.2

X Walk 1 X Slope (%)	1.9		X Walk 2	K Slope (%)	10.4
N/A	Ramp inside XWalk1?	N/A	N/A	Ramp insi	de XWalk2?	N/A
	Road Slope (%)	10.9	N/A	Clear Spa	ce?	N/A
	Road X Slope (%)	3.5	N/A	Clear Spa	ce to XWalk (in)	N/A
N/A	Any Obstructions?	N/A	N/A	Storm Gra	te/Utility Hazard?	N/A

Remove & Replace Curb Ramp With
Two New Directional Ramps or
Equivalent.
