Access Compliance Report

Public Rights-of-Way

(Curb Ramps)

Intersection ID: 3105	Main Street: DEARMON_RD	Cross Street: BROWNE_RD	Location: SW
ADA ID: 14446DA90244	Ramp Type: Perp	Initial Pass/Fail: Fail	Overall Compliance: No
Severity Score: 33.75			
Codes/Mitigation Info/Possible Solution		Field Measurements/Component Compliance

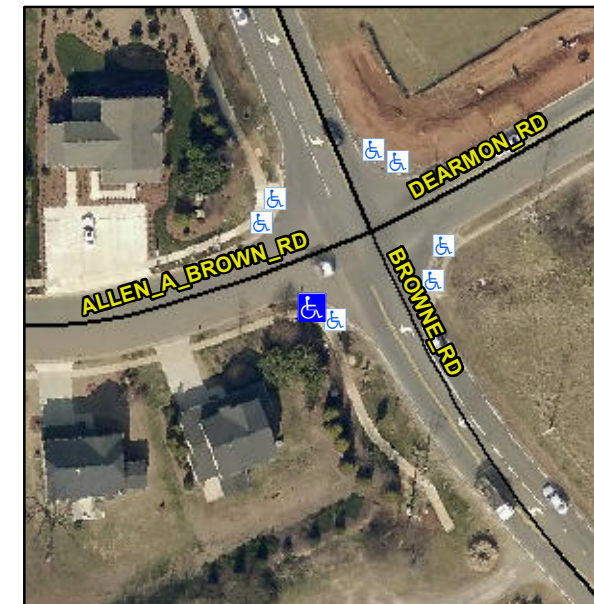
R304.5.1, R304.2.2

Compliance	Description	Data	Compliance	Description	Data
N/A	Ramp Length (in)	51.5	No	Ramp Slope (%)	15.2
No	Ramp Width (in)	47.0	Yes	Ramp XSlope (%)	0.4
N/A	Flare Type LT	N/A	N/A	Flare Type RT	N/A
N/A	Flare Slope LT (%)	N/A	N/A	Flare Slope RT (%)	N/A
N/A	Flare Traversable LT?	N/A	N/A	Flare Traversable RT?	N/A
N/A	Landing Length (in)	N/A	N/A	DWS Provided?	N/A
N/A	Landing Width (in)	N/A	N/A	DWS Contrast?	N/A
N/A	Landing Slope (%)	N/A	N/A	DWS Length (in)	N/A
N/A	Landing X Slope (%)	N/A	N/A	DWS Full Width?	N/A
N/A	Landing Curb? (Y/N)	N/A	N/A	DWS Offset (in)	N/A
N/A	Shared Landing?	N/A			
N/A	Gutter Ponding?	N/A	N/A	Gutter Slope (%)	N/A
N/A	Gutter Lip Ht (in)	N/A	N/A	Gutter X Slope (%)	N/A
N/A	Painted X Walk1?	Yes	N/A	Painted X Walk2?	N/A
	X Walk 1 Direction	To N		X Walk 2 Direction	N/A
N/A	X Walk 1 Width (in)	106.0	N/A	X Walk 2 Width (in)	N/A
	X Walk 1 Slope (%)	3.1		X Walk 2 Slope (%)	N/A
	X Walk 1 X Slope (%)	2.0		X Walk 2 X Slope (%)	N/A

N/A	Ramp inside XWalk1?	Yes	N/A	Ramp inside XWalk2?	N/A
	Road Slope (%)	N/A	N/A	Clear Space?	N/A
	Road X Slope (%)	N/A	N/A	Clear Space to XWalk (in)	N/A
N/A	Any Obstructions?	N/A	N/A	Storm Grate/Utility Hazard?	N/A
	Obstruction Type			Storm Grate/Utility Type	
		N/A			N/A
		Yes		Surface Condition? (G/P)	Good

Possible Solutions:

Remove & Replace Entire Ramp.
