Access Compliance Report

Public Rights-of-Way

(Curb Ramps)

Intersection ID: 10028782	Main Street: HUNTINGTOWNE_FARMS_LN	Cross Street: N/A	Location: S
ADA ID: 144B4C0173E6	Ramp Type: Perp	Initial Pass/Fail: Fail	Overall Compliance: No
Codes/Mitigation Info/Possible Solution		Field Measurements/Component Compliance	
Severity Score: 13.75

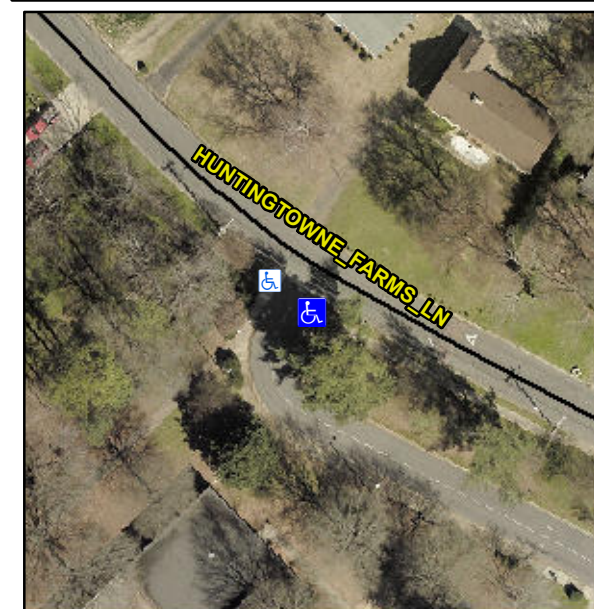
Not Found, R304.2.2, R304.5.3

Compliance	Description	Data	Compliance	Description	Data
N/A	Ramp Length (in)	60.5	No	Ramp Slope (%)	8.7
Yes	Ramp Width (in)	48.0	No	Ramp XSlope (%)	4.4
N/A	Flare Type LT	N/A	N/A	Flare Type RT	N/A
N/A	Flare Slope LT (%)	N/A	N/A	Flare Slope RT (%)	N/A
N/A	Flare Traversable LT?	N/A	N/A	Flare Traversable RT?	N/A
N/A	Landing Length (in)	N/A	N/A	DWS Provided?	N/A
N/A	Landing Width (in)	N/A	N/A	DWS Contrast?	N/A
N/A	Landing Slope (%)	N/A	N/A	DWS Length (in)	N/A
N/A	Landing X Slope (%)	N/A	N/A	DWS Full Width?	N/A
N/A	Landing Curb? (Y/N)	N/A	N/A	DWS Offset (in)	N/A
N/A	Shared Landing?	N/A			
N/A	Gutter Ponding?	N/A	N/A	Gutter Slope (%)	N/A
N/A	Gutter Lip Ht (in)	N/A	N/A	Gutter X Slope (%)	N/A
N/A	Painted X Walk1?	No	N/A	Painted X Walk2?	N/A
	X Walk 1 Direction	To NW		X Walk 2 Direction	N/A
N/A	X Walk 1 Width (in)	N/A	N/A	X Walk 2 Width (in)	N/A
	X Walk 1 Slope (%)	1.6		X Walk 2 Slope (%)	N/A
	X Walk 1 X Slope (%)	1.5		X Walk 2 X Slope (%)	N/A

N/A	Ramp inside XWalk1?	N/A	N/A	Ramp inside XWalk2?	N/A
	Road Slope (%)	N/A	N/A	Clear Space?	N/A
	Road X Slope (%)	N/A	N/A	Clear Space to XWalk (in)	N/A
N/A	Any Obstructions?	N/A	N/A	Storm Grate/Utility Hazard?	N/A
	Obstruction Type			Storm Grate/Utility Type	
		N/A			N/A
			Yes	Surface Condition? (G/P)	Good

Possible Solutions:

Remove & Replace Entire Ramp.

Total Cost: \$ 1850.00
