Access Compliance Report

Public Rights-of-Way

(Curb Ramps)

Intersection ID: 12620	Main Street: JOHN_CROSLAND_JR_DR	Cross Street: HARGROVE_AV	Location: NW
ADA ID: 144DAD91BF48	Ramp Type: PerpDiag	Initial Pass/Fail: Fail	Overall Compliance: No
Severity Score: 33.75			
Codes/Mitigation Info/Possible Solution		Field Measurements/Component Compliance

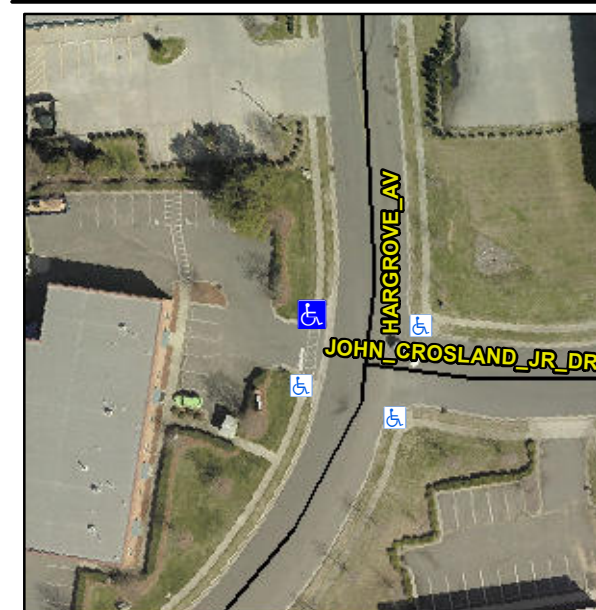
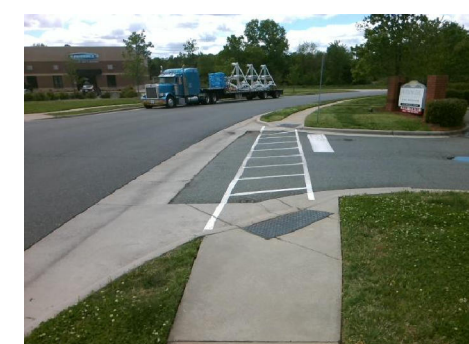
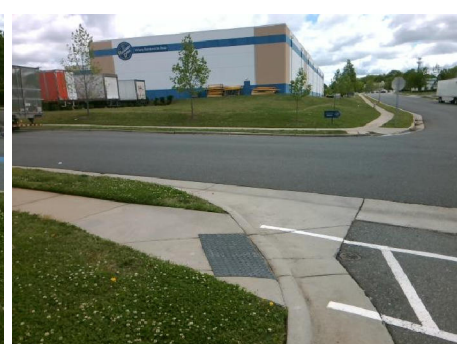
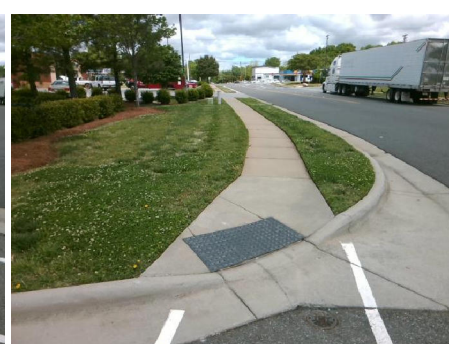
Compliance	Description	Data	Compliance	Description	Data
N/A	Ramp Length (in)	35.0	No	Ramp Slope (%)	13.4
No	Ramp Width (in)	36.0	Yes	Ramp XSlope (%)	0.6
N/A	Flare Type LT	N/A	N/A	Flare Type RT	N/A
N/A	Flare Slope LT (%)	N/A	N/A	Flare Slope RT (%)	N/A
N/A	Flare Traversable LT?	N/A	N/A	Flare Traversable RT?	N/A
N/A	Landing Length (in)	N/A	N/A	DWS Provided?	N/A
N/A	Landing Width (in)	N/A	N/A	DWS Contrast?	N/A
N/A	Landing Slope (%)	N/A	N/A	DWS Length (in)	N/A
N/A	Landing X Slope (%)	N/A	N/A	DWS Full Width?	N/A
N/A	Landing Curb? (Y/N)	N/A	N/A	DWS Offset (in)	N/A
N/A	Shared Landing?	N/A			
N/A	Gutter Ponding?	N/A	N/A	Gutter Slope (%)	N/A
N/A	Gutter Lip Ht (in)	N/A	N/A	Gutter X Slope (%)	N/A
N/A	Painted X Walk1?	Yes	N/A	Painted X Walk2?	No
	X Walk 1 Direction	To S		X Walk 2 Direction	To E
N/A	X Walk 1 Width (in)	55.0	N/A	X Walk 2 Width (in)	N/A
	X Walk 1 Slope (%)	4.2		X Walk 2 Slope (%)	3.3
	X Walk 1 X Slope (%)	0.8		X Walk 2 X Slope (%)	2.3

N/A	Ramp inside XWalk1?	Yes	N/A	Ramp inside XWalk2?	N/A
	Road Slope (%)	0.7	N/A	Clear Space?	N/A
	Road X Slope (%)	1.4	N/A	Clear Space to XWalk (in)	N/A
N/A	Any Obstructions?	N/A	N/A	Storm Grate/Utility Hazard?	N/A
	Obstruction Type			Storm Grate/Utility Type	
		N/A			N/A
		Yes		Surface Condition? (G/P)	Good

Remove & Replace Curb Ramp With Two New Directional Ramps or Equivalent.

R304.5.1, R304.2.2
