# Access Compliance Report

## Public Rights-of-Way

### (Curb Ramps)

Intersection ID: N/A	Main Street: VISTA_VERDE_CT	Cross Street: N/A	Location: NE
ADA ID: 144E03D85959	Ramp Type: Perp	Initial Pass/Fail: Fail	Overall Compliance: No
Severity Score: 12.5			
Codes/Mitigation Info/Possible Solution		Field Measurements/Component Compliance

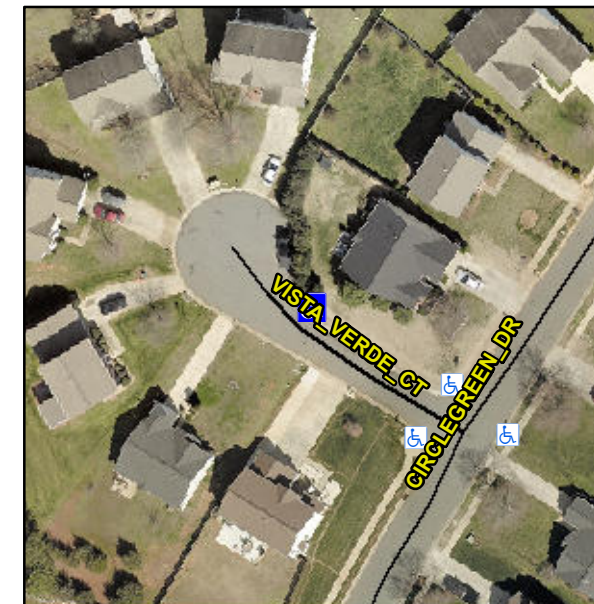
Compliance	Description	Data	Compliance	Description	Data
N/A	Ramp Length (in)	48.0	No	Ramp Slope (%)	10.1
Yes	Ramp Width (in)	48.0	Yes	Ramp XSlope (%)	0.4
N/A	Flare Type LT	N/A	N/A	Flare Type RT	N/A
N/A	Flare Slope LT (%)	N/A	N/A	Flare Slope RT (%)	N/A
N/A	Flare Traversable LT?	N/A	N/A	Flare Traversable RT?	N/A
N/A	Landing Length (in)	N/A	N/A	DWS Provided?	N/A
N/A	Landing Width (in)	N/A	N/A	DWS Contrast?	N/A
N/A	Landing Slope (%)	N/A	N/A	DWS Length (in)	N/A
N/A	Landing X Slope (%)	N/A	N/A	DWS Full Width?	N/A
N/A	Landing Curb? (Y/N)	N/A	N/A	DWS Offset (in)	N/A
N/A	Shared Landing?	N/A			
N/A	Gutter Ponding?	N/A	N/A	Gutter Slope (%)	N/A
N/A	Gutter Lip Ht (in)	N/A	N/A	Gutter X Slope (%)	N/A
N/A	Painted X Walk1?	No	N/A	Painted X Walk2?	N/A
	X Walk 1 Direction	To SW		X Walk 2 Direction	N/A
N/A	X Walk 1 Width (in)	N/A	N/A	X Walk 2 Width (in)	N/A
	X Walk 1 Slope (%)	4.9		X Walk 2 Slope (%)	N/A
	X Walk 1 X Slope (%)	2.5		X Walk 2 X Slope (%)	N/A

N/A	Ramp inside XWalk1?	N/A	N/A	Ramp inside XWalk2?	N/A
	Road Slope (%)	N/A	N/A	Clear Space?	N/A
	Road X Slope (%)	N/A	N/A	Clear Space to XWalk (in)	N/A
N/A	Any Obstructions?	N/A	N/A	Storm Grate/Utility Hazard?	N/A
	Obstruction Type			Storm Grate/Utility Type	
		N/A			N/A
		Yes		Surface Condition? (G/P)	Good

Possible Solutions:

**Remove & Replace Entire Ramp.**

**R304.2.2**

**\$ 1850.00**
